FACILITY CONDITION ASSESSMENT

PALOS VERDES PENINSULA UNIFIED SCHOOL DISTRICT
MIRALESTE MIDDLE SCHOOL
29323 PALOS VERDES DRIVE
RANCHO PALOS VERDES. CALIFORNIA 90275

119663.16R000-011.017

May 8, 2017

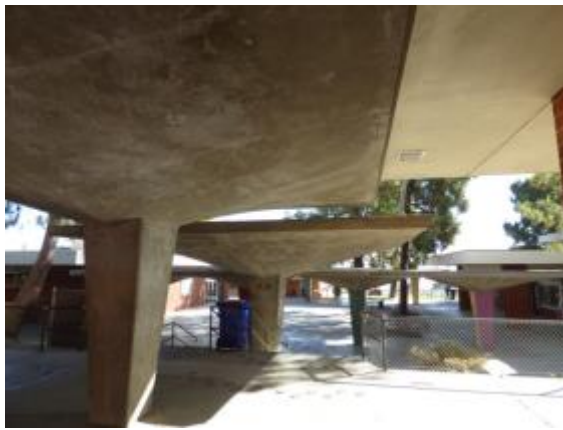
Photo #9: Concrete shade structures between classroom buildings (see damages photo #48)

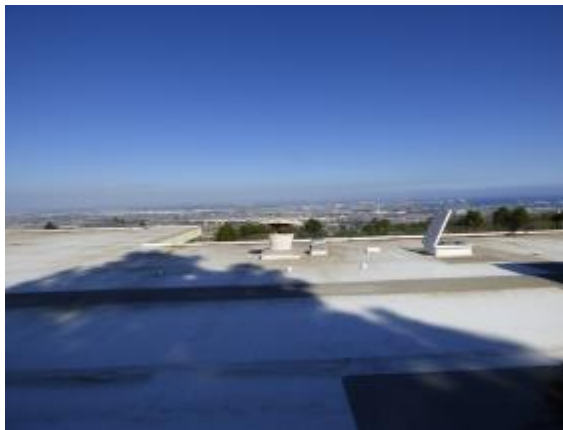
Photo #15: TPO Roof

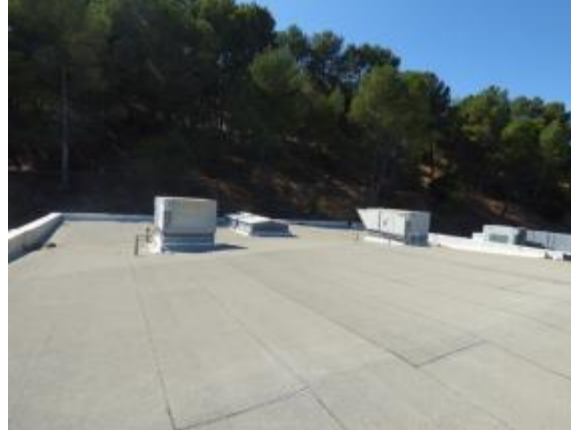
Photo #16: Modified built up roof above TAB building

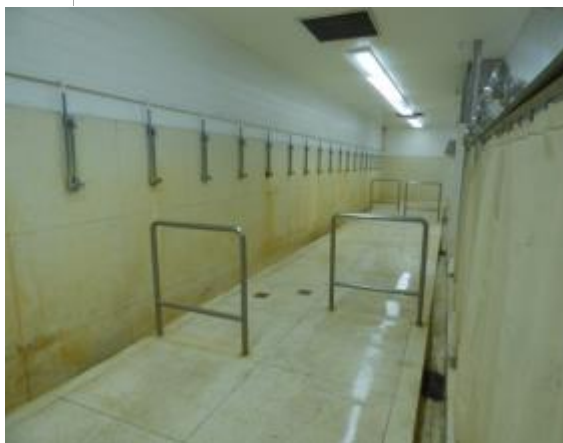
Photo #29: Locker room deteriorating showers

6.3	589545	Roof, Modified Bituminous, Repair	1400	SF	\$2.20	\$3,083	\$3,083
7.2	526317	Shower Head, Station or Column, Commercial Grade, Replace	24	EA	\$2,880.50	\$69,132	\$69,132

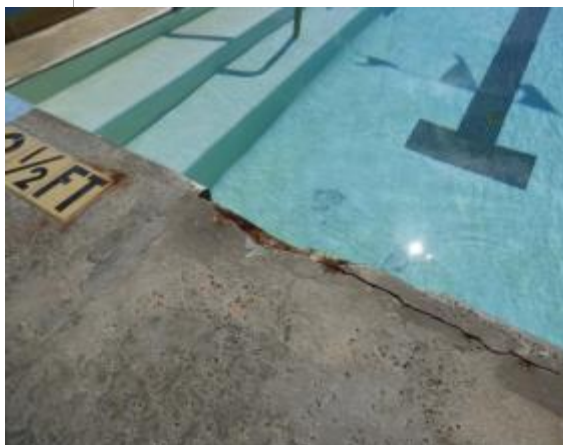
Photo #53: Pool gutter concrete damages

5.5	505380	Foundations, 9950 SF Concrete pool deck, replace	9950	SF	\$10.44	\$103,878	\$103,878
5.5	505345	Swimming Pool Gutter System, 320 LF, Replace	320	LF	\$455.71	\$145,827	\$145,827

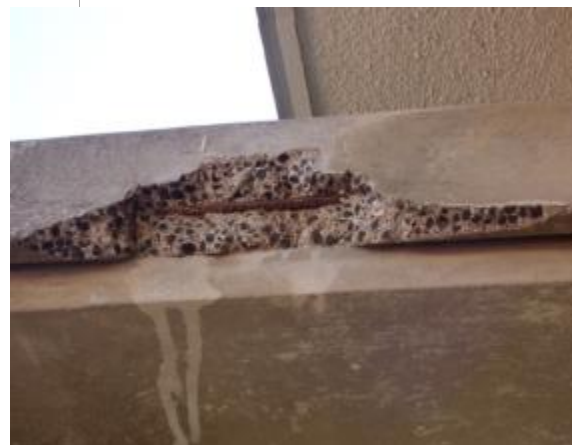
- Address spalling concrete issues at walkway canopies
- Repair Swimming Pool gutter system and coping
- Repair locker room showers
- Evaluate air quality and effectiveness of HVAC
- Repair active roof leaks

Photo #54: Concrete damage at shade structures
