FACILITY CONDITION ASSESSMENT

FACILITY CONDITION ASSESSMENT
OF
RIDGECREST MIDDLE SCHOOL
28915 NORTHBAY ROAD
RANCHO PALOS VERDES, CALIFORNIA 90275

EMG
10461 Mill Run Circle, Suite 1100
Owings Mills, Maryland 21117
800.733.0660
www.EMGcorp.com

January 13, 2017

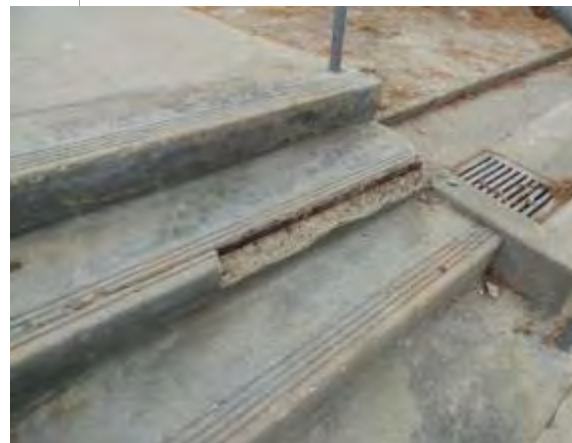
Photo #30: Damaged nosing close-up at exterior walkway stair

1.3	526649 Termites, , Investigation and Treatment	1	EA	\$3,162.50	\$3,163	\$3,163
5.2	526653 Exterior Stairs & Ramps, Concrete (per LF of Nosing), Repair	400	LF	\$8.54	\$3,416	\$3,416

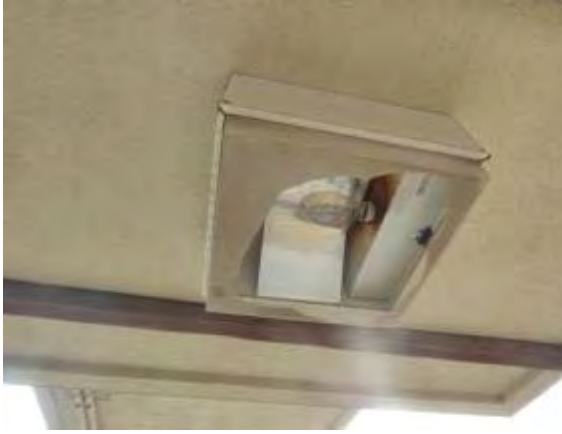
Photo #37: Damaged soffit lighting at walkway roof

5.5	538013 LED Light Fixture, Exterior, Soffit Mount, Replace existing	24	EA	\$425.19	\$10,204	\$10,204
5.5	538014 Pole Light w/Concrete Base, Exterior, 105 to 200 W LED, Install new	4	EA	\$8,803.00	\$35,212	\$35,212

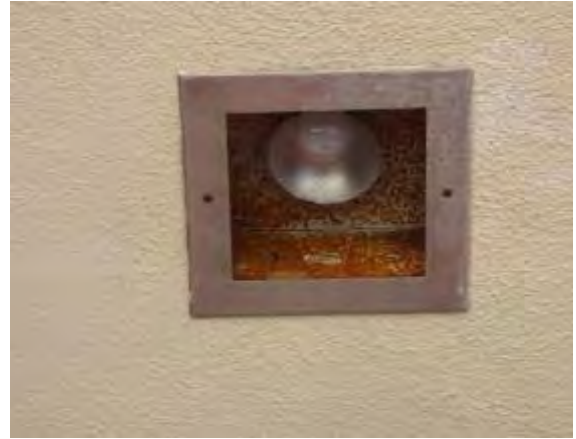
Photo #38: Corroded soffit lighting at walkway roof

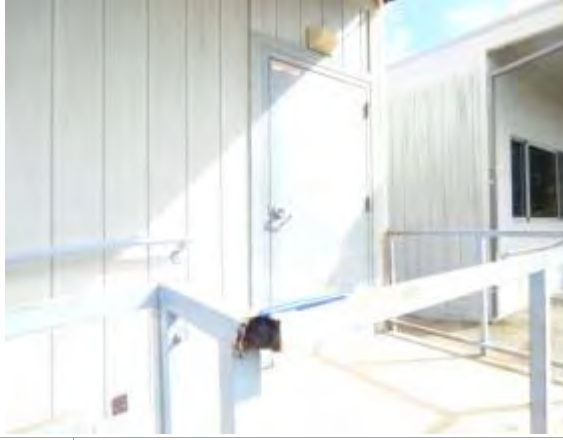
- There is evidence of wood framing deterioration due to insect infestation at the portable classroom structures. A local, licensed exterminator must be retained to treat the property as required to eliminate the pests and associated threat. The cost of this study is included in the cost tables.

Photo #49: Damages at classroom portable building entry door and ramp

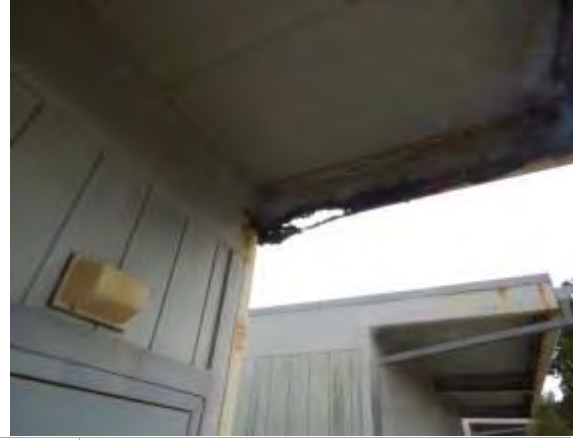
Photo #50: Damages at portable classroom roof edge

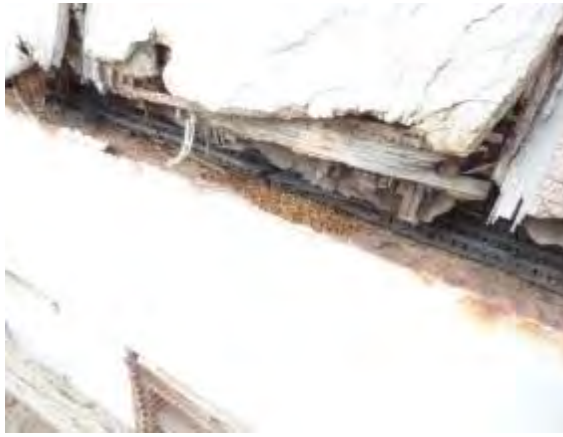
Photo #51: Damages at portable classroom wall near ground level

6.4	538015 Exterior Wall, Textured Plywood (T1-11), Replace	1600	SF	\$11.59	\$18,545	\$18,545
6.6	538017 Overhead Door, Steel Roll-Up 144 SF, Replace	1	EA	\$2,839.33	\$2,839	\$2,839
