FACILITY CONDITION ASSESSMENT

PALOS VERDES PENINSULA UNIFIED SCHOOL DISTRICT
SOLEADO ELEMENTARY
27800 LONGHILL DRIVE
RANCHO PALOS VERDES. CALIFORNIA 90275

119663.16R000-008.017

November 30, 2016

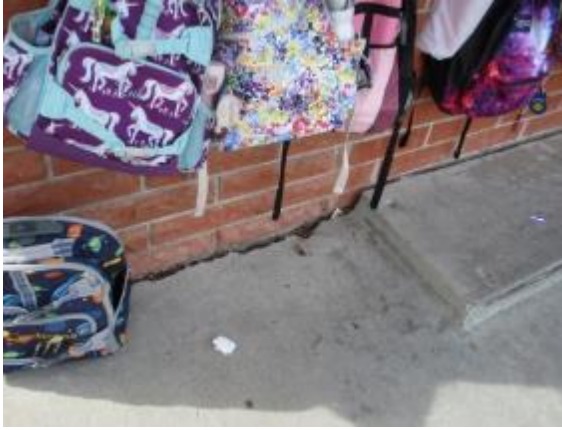
Photo #43: Crack at concrete due to settlement

5.2	Around modular classrooms	505686	Parking Lots, Asphalt Pavement, Cut & Patch	400	SF	\$4.96	\$1,984	\$1,984
5.2	Northeast corner of Vista building	505960	Pedestrian Pavement, Sidewalk, Concrete, Remove, re-compact, replace	300	SF	\$28.94	\$8,683	\$8,683

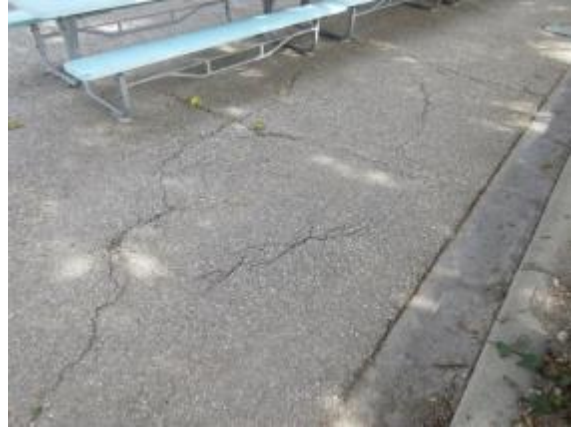
Photo #44: Cracks on asphalt pavement around modular classrooms

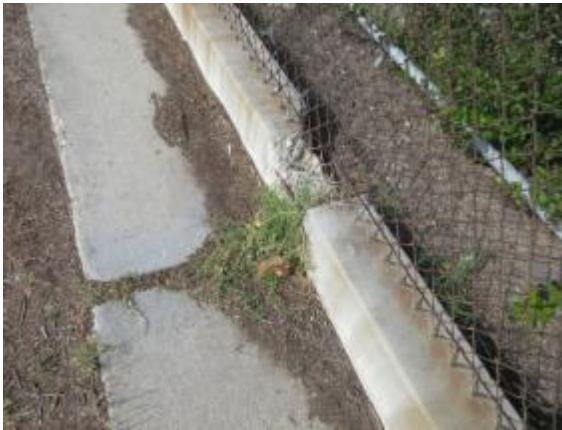
Photo #45: Cracks on curb at east property fence

Report Section	Location Description	ID	Cost Description	Quantity	Unit	Unit Cost	Subtotal	Deficiency Repair Estimate *
5.2	North and east property fence	505688	Roadways, Concrete Curb & Gutter, Repair	30	LF	\$24.02	\$721	\$721

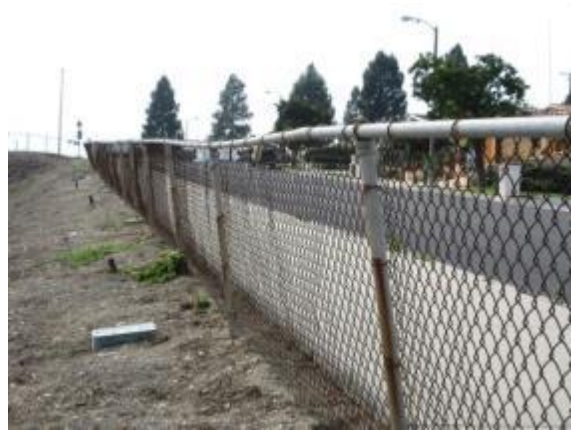
Photo #46: West property fence that is leaning

5.5	West property line	504927	Fences & Gates, Chain Link, 4' High, Replace	30	29	1	380	LF	\$30.51	\$11,594		\$11,594																			\$11,594	
5.5	Throughout property	504918	Fences & Gates, Chain Link, 8' High, Replace	30	21	9	1100	LF	\$53.90	\$59,290									\$59,290												\$59,290

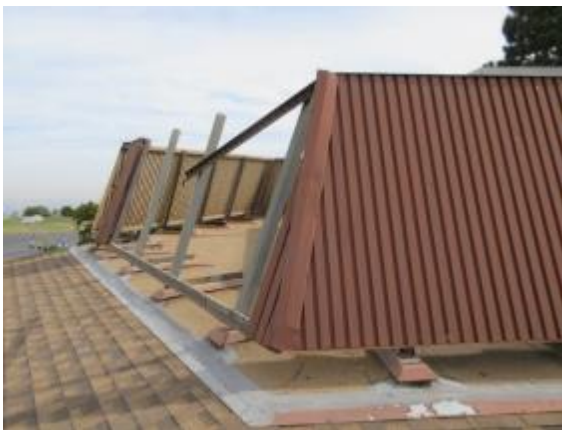
Photo #47: Damaged architectural roof screen

5.5	Parking lot	504913	Pole Light, Exterior, 135 to 1000 W HID (Double Fixture, with Metal Pole), Replace	5	EA	\$8,523.34	\$42,617	\$42,617
6.3	Permanent building roofs	505966	Equipment Screen Wall, Corrugated Metal, Roof Mounted, Repair	150	SF	\$7.34	\$1,101	\$1,101
