FACILITY CONDITION ASSESSMENT

PALOS VERDES PENINSULA UNIFIED SCHOOL DISTRICT
SILVER SPUR ELEMENTARY SCHOOL
5500 IRONWOOD STREET
RANCHO PALOS VERDES. CALIFORNIA 90275

119663.16R000-007.017

November 22, 2016

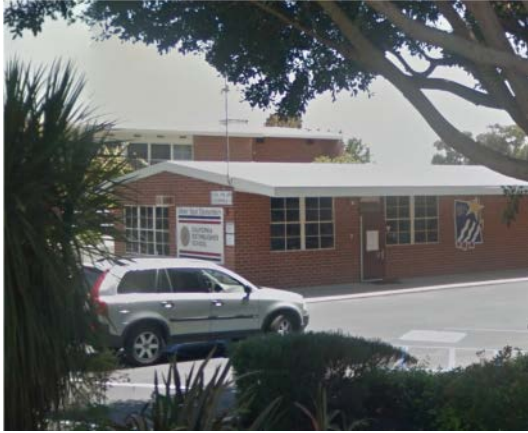
Photo #1: Admin Building Southwest Elevation

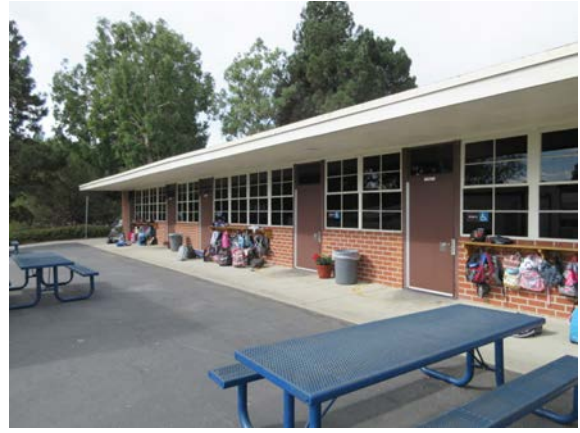
Photo #2: Classroom Building Exterior

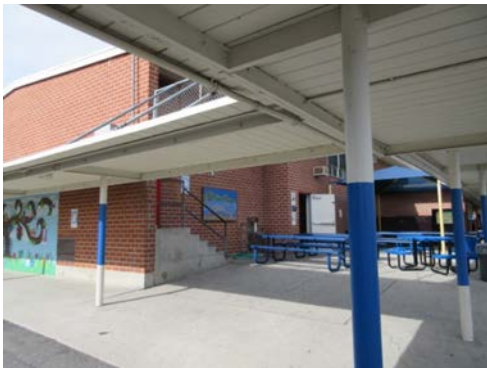
Photo #3: Covered Walkways and MPR Building

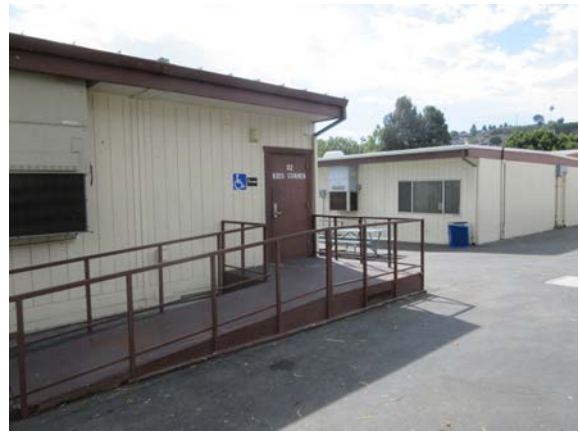
Photo #4: Portable Classroom Buildings

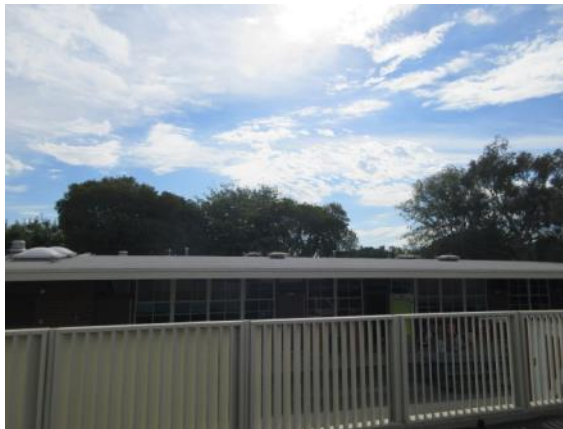
Photo #5: Roof of Building

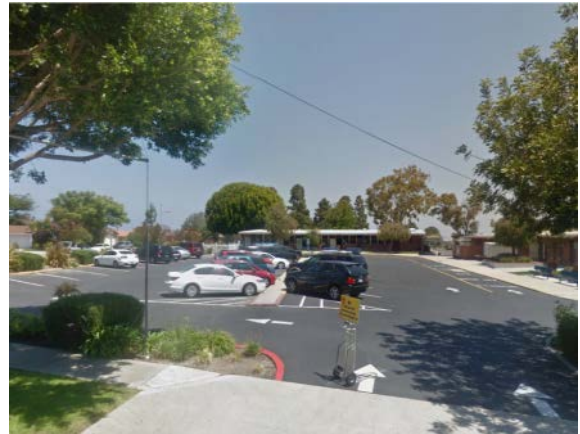
Photo #6: School Parking Lot

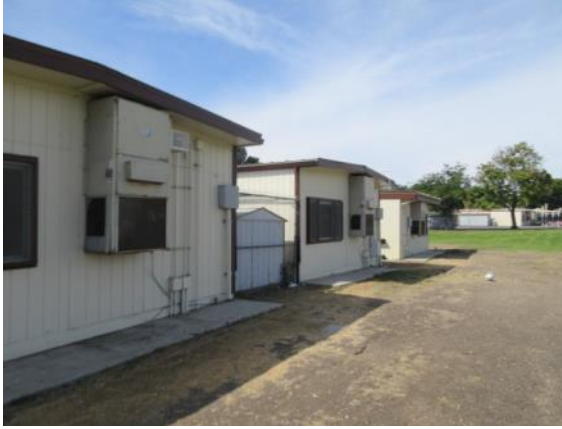
Photo #7: Exterior of Portable Classrooms

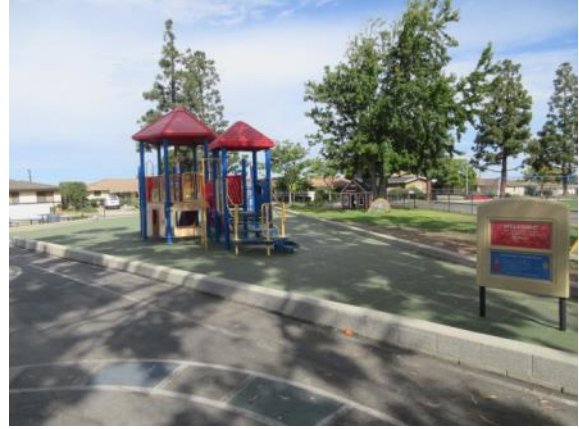
Photo #8: Playground Equipment at Kindergarten

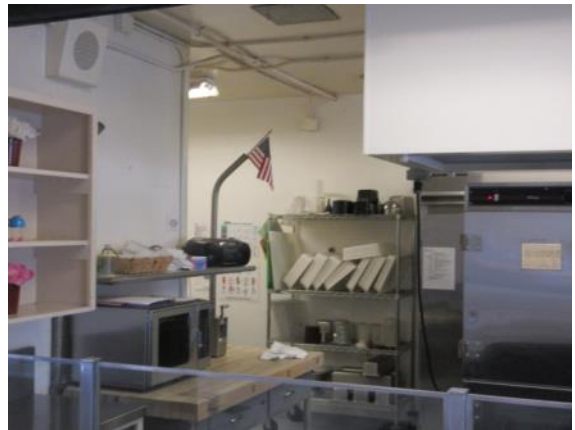
Photo #16: Kitchen At MPR

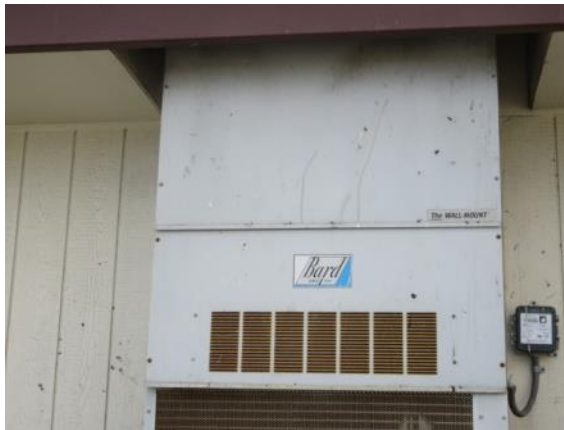
Photo #21: Wall Mounted HVAC Package Unit

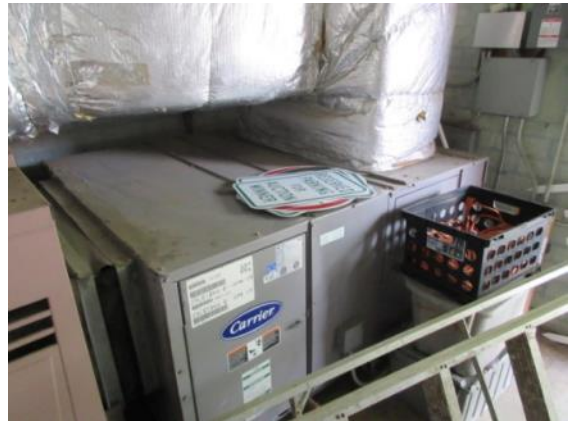
Photo #22: Furnace at MPR

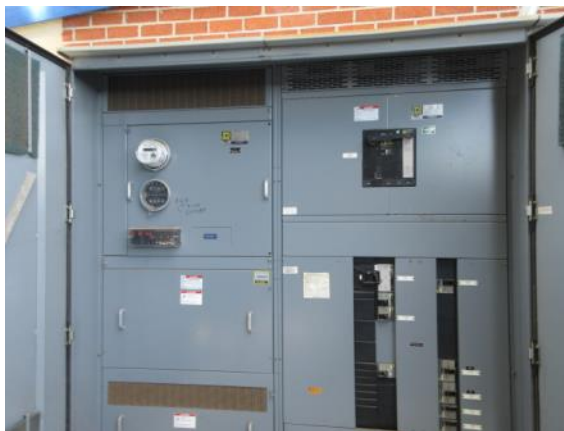
Photo #23: Main Electric Panel

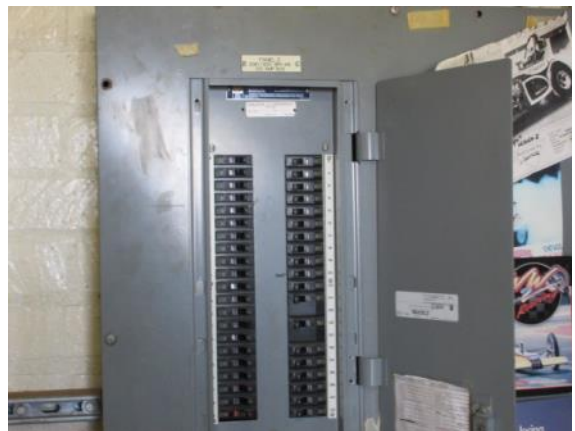
Photo #24: Electrical Distribution Panel

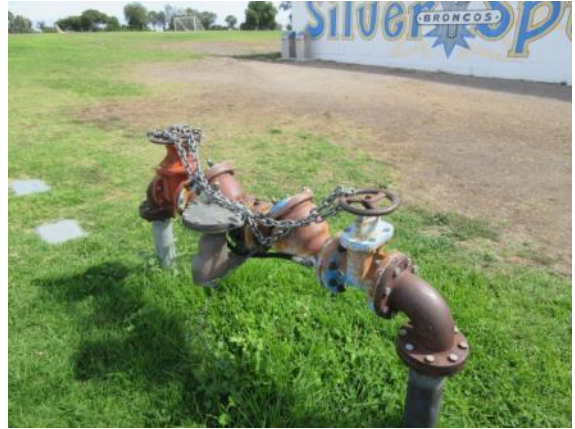
Photo #26: Water Service, Irrigation

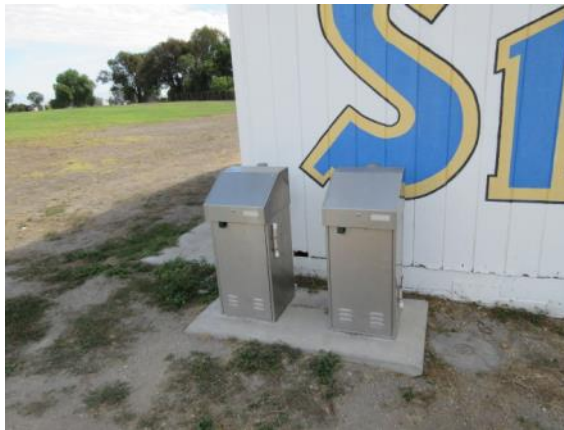
Photo #27: Irrigation Controllers

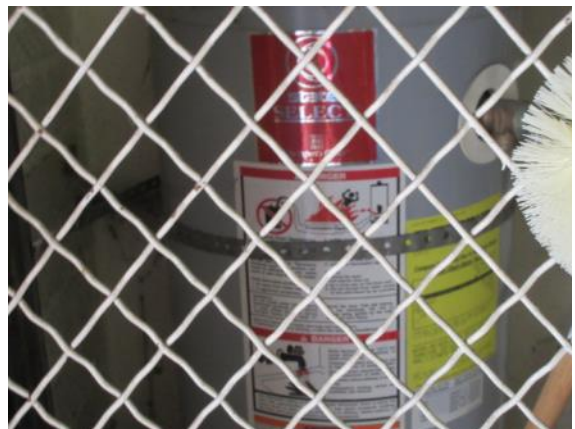
Photo #30: Water Heater

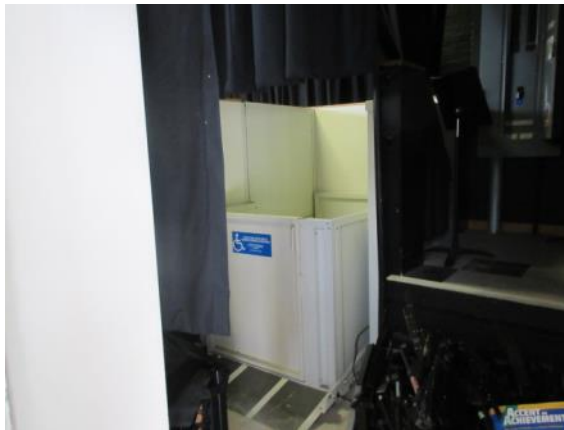
Photo #33: Wheelchair Lift at MPR

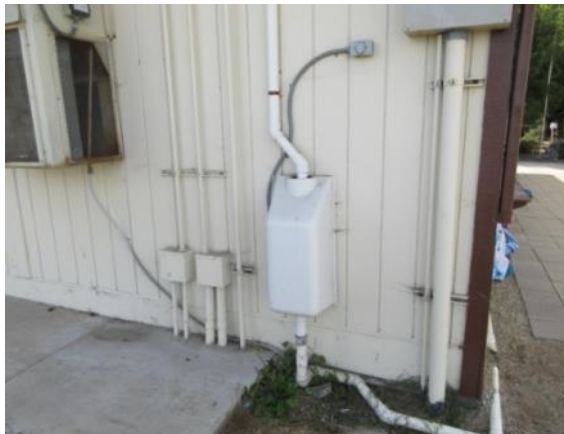
Photo #35: Radon Gas Detector And Evacuation System

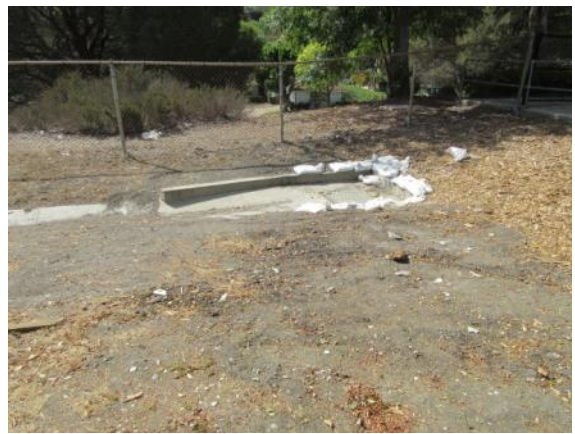
Photo #36: Storm Drain Inlet
