Palos Verdes Peninsula Unified School District

Seismic Structural Evaluation and Recommendations

September 9, 2016

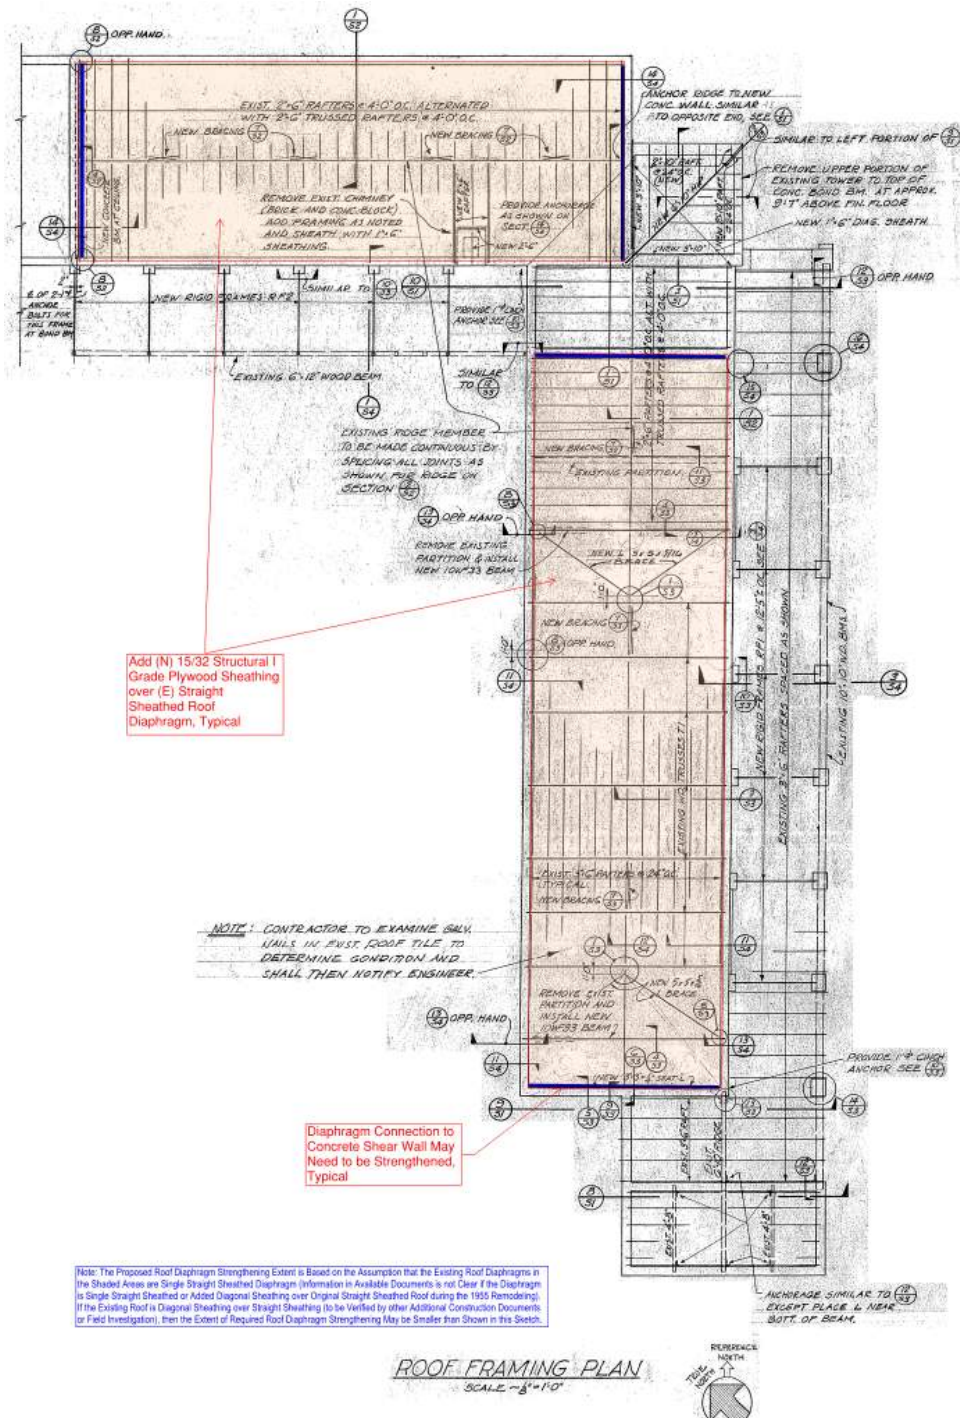
Sketch 1 – Classroom Building Portion B, Proposed Strengthening of Roof Diaphragms
(Based on Existing 1955 Drawing S-3)

The remaining deficiencies for Portion B of the building are due to the fact that the straight sheathed roof diaphragms do not have the capacity for large spans and aspect ratio. The deficiency in straight sheathed diaphragm may pose a serious collapse hazard if not mitigated.

1. Provide new structural roof diaphragm panel overlays over the existing roof diaphragms (See Sketch 1). The new added plywood diaphragm will increase the capacity for the roof diaphragms and allow longer diaphragm span and larger aspect ratios than the existing straight sheathed diaphragm condition. This will mitigate the deficiency of straight sheathed diaphragm in Portion B roof. Final extents of added plywood diaphragms and other details will be further developed in future structural upgrading work.

Adding new plywood diaphragm sheathing over existing roof diaphragm will eliminate the deficiency of inadequate capacity of the existing straight sheathed diaphragms. See retrofit Sketch 1 for the proposed diaphragm strengthening scheme.

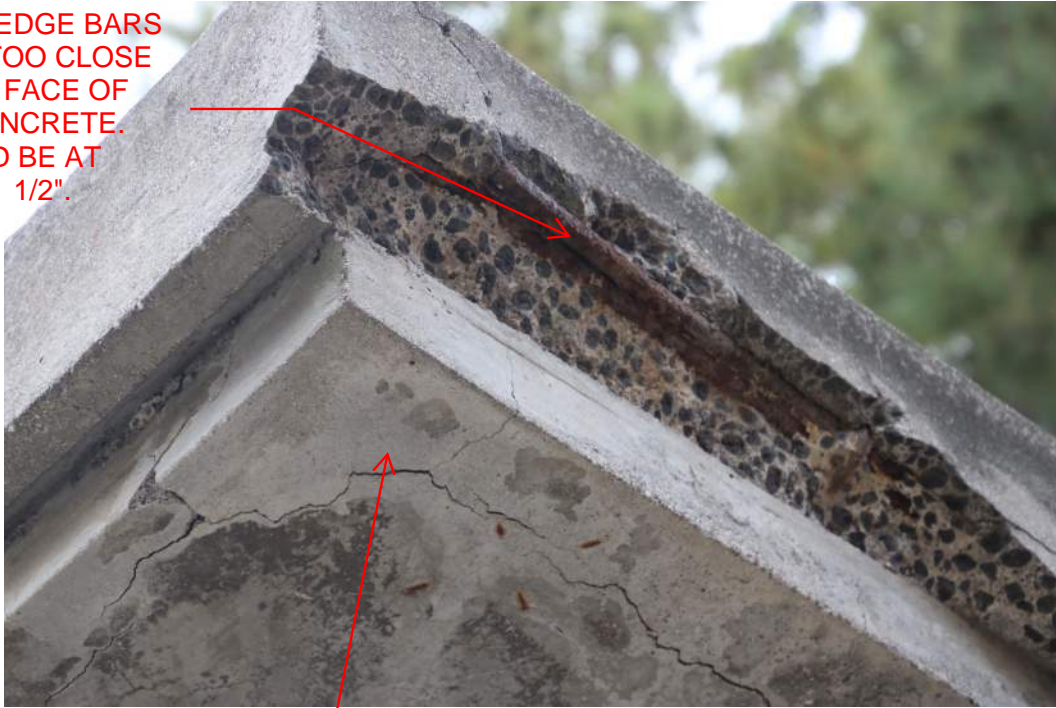
FIG. 1

THESE EDGE BARS
WERE TOO CLOSE
TO THE FACE OF
THE CONCRETE.
SHOULD BE AT
LEAST 1 1/2".

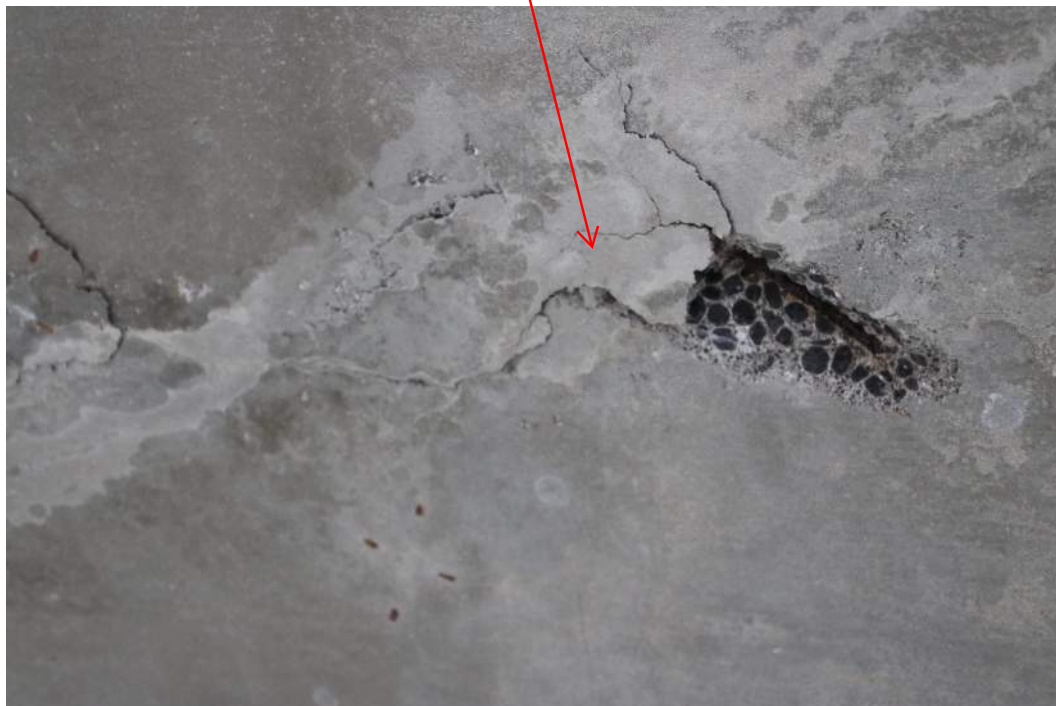
FIG. 2

CONCRETE DE-LAMINATING
FROM THE UNDERSIDE OF
THE CANOPY. LOOSE
MATERIAL SHOULD BE
REMOVED.

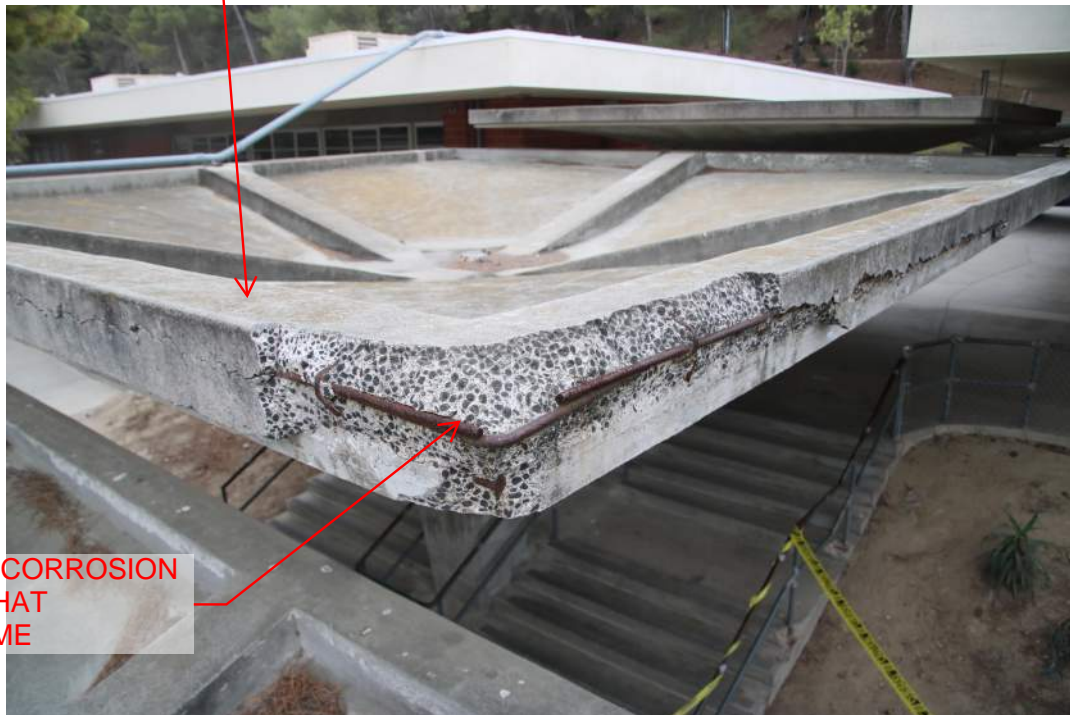
FLAT SURFACE FOR
WATER TO STAND
AND ABSORB IN

REBAR CORROSION
ISN'T THAT
EXTREME

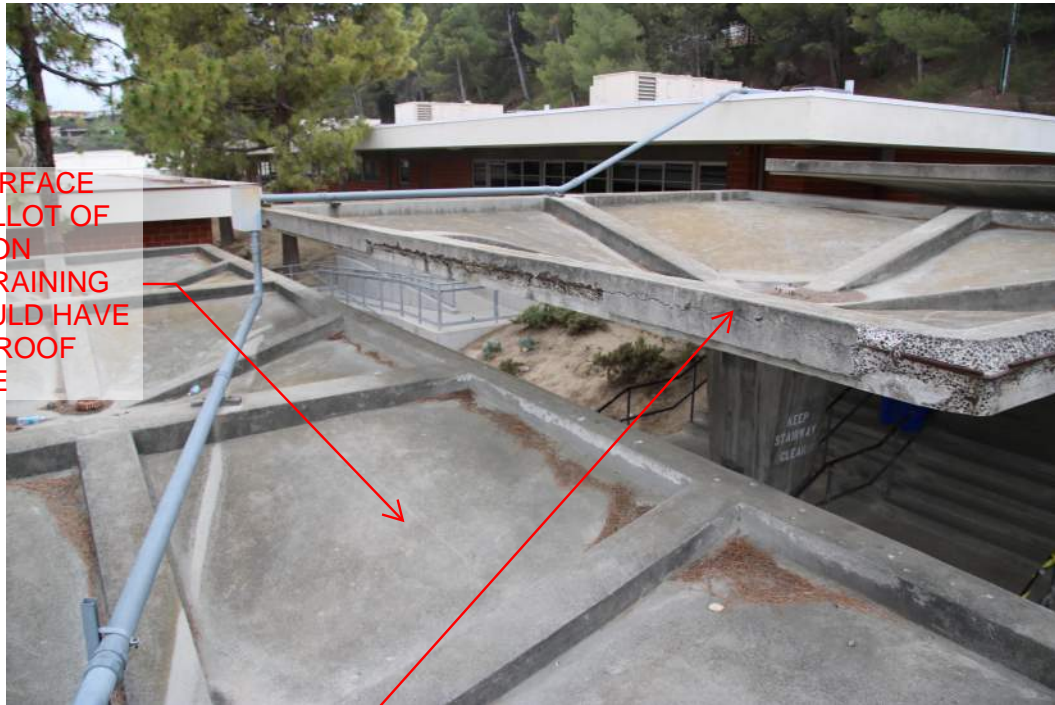
ROUGH SURFACE
ALLOWS ALOT OF
ABSORPTION
BEFORE DRAINING
OFF. SHOULD HAVE
A WATERPROOF
MEMBRANE

MORE CRACKING THAT
WILL SPALL IN TIME.
LOOSE MATERIAL
SHOULD BE REMOVED
