Palos Verdes Peninsula Unified School District

Seismic Structural Evaluation and Recommendations

September 9, 2016

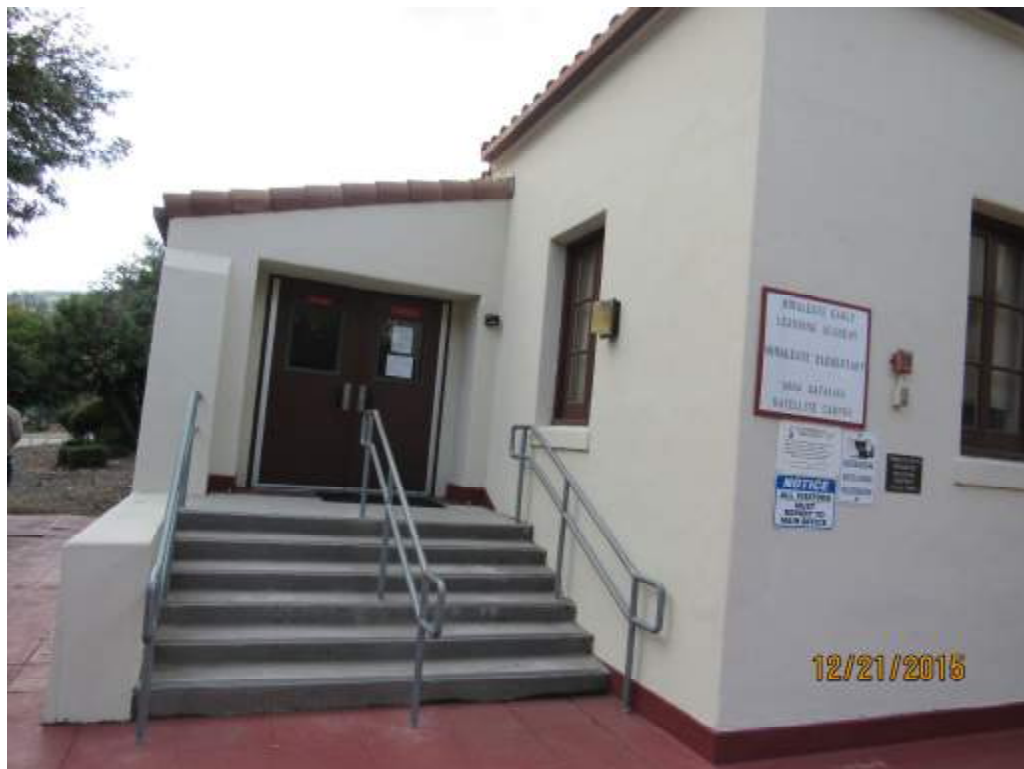
Photo 1 – View of East Entrance of the Classroom Building

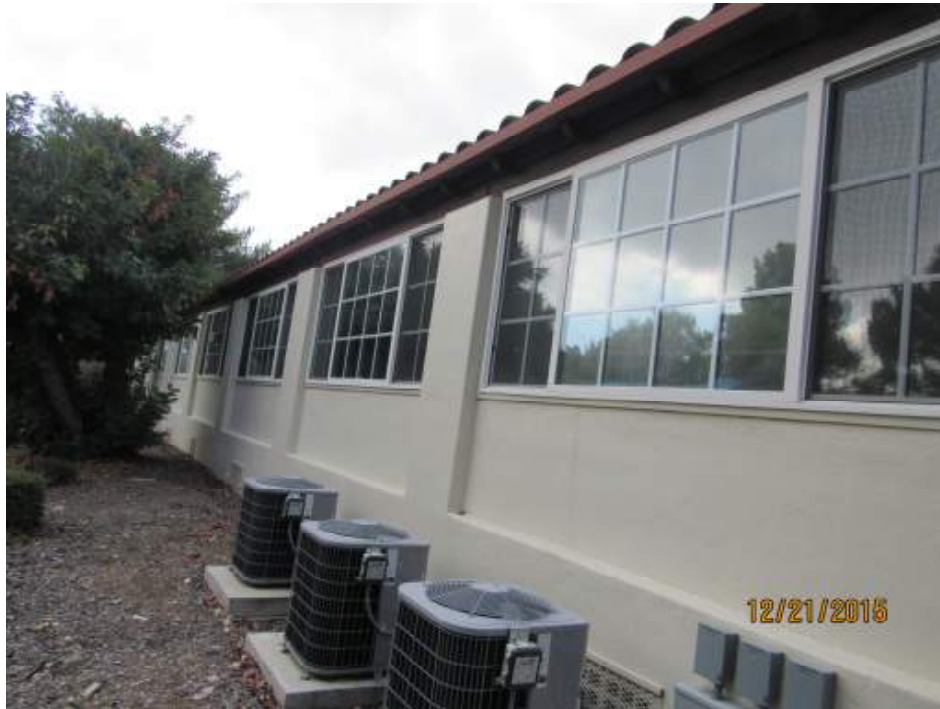
Photo 2 – View of South Elevation of the Building

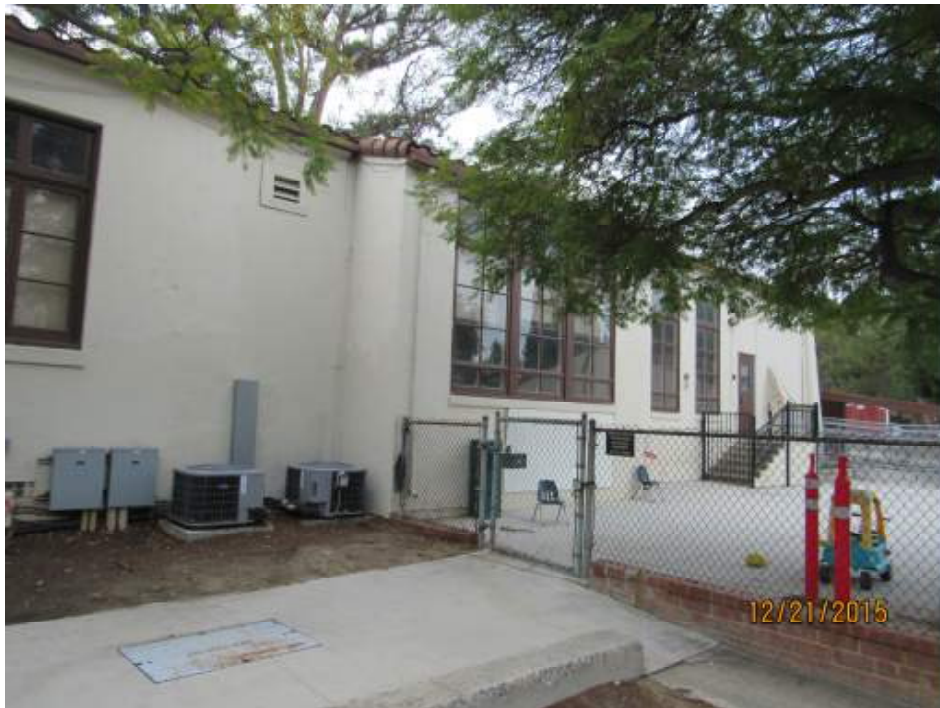
Photo 3 – View of North-East Elevation of the Building

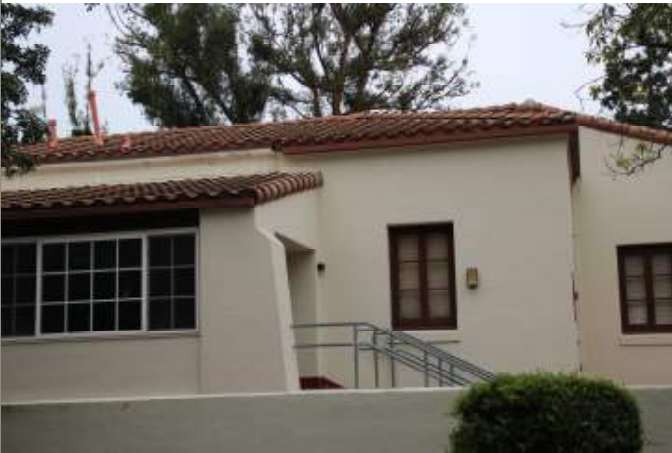
Fig 1. Entry with former tower location

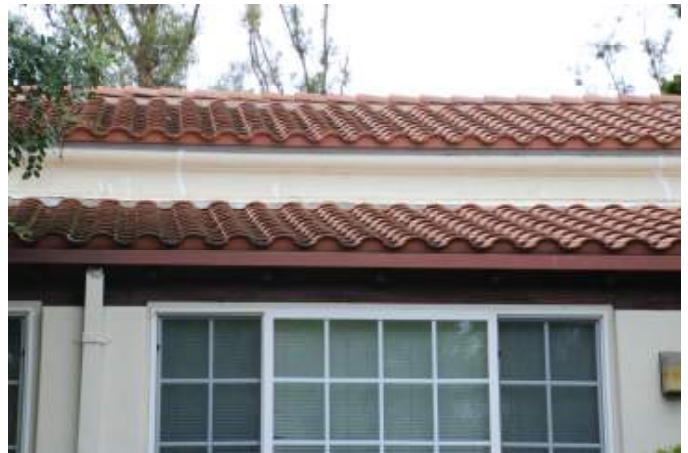
Fig 2. Roof tile at high and low roofs

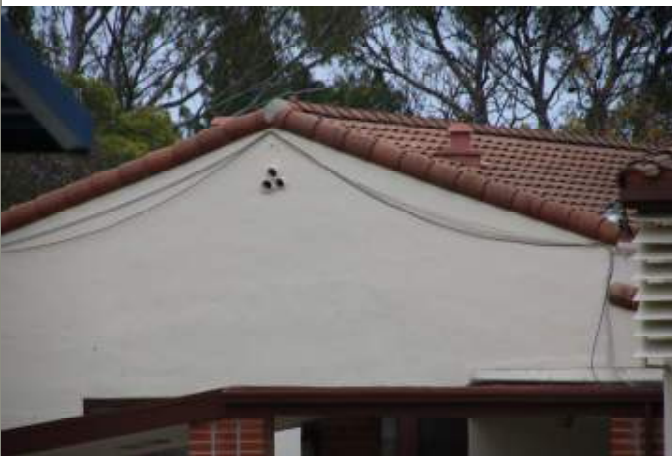
Fig 3. Gable end of main roof

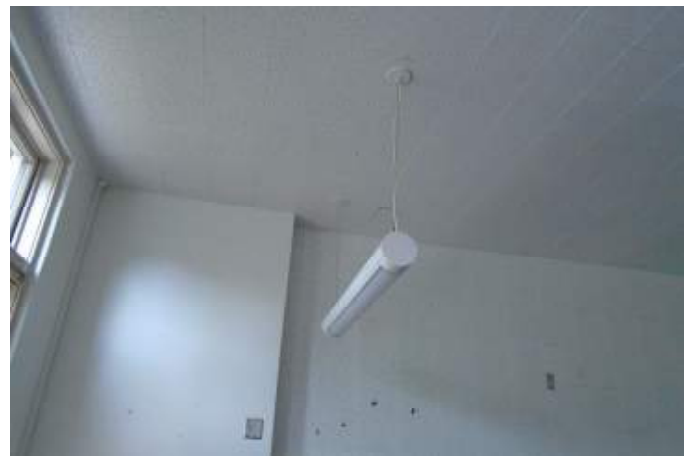
Fig 4. Typical classroom ceiling

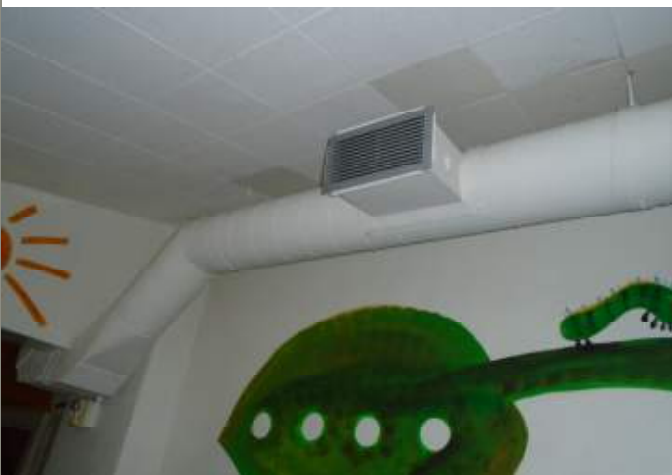
Fig 5. Ceiling at enclosed colonnade area

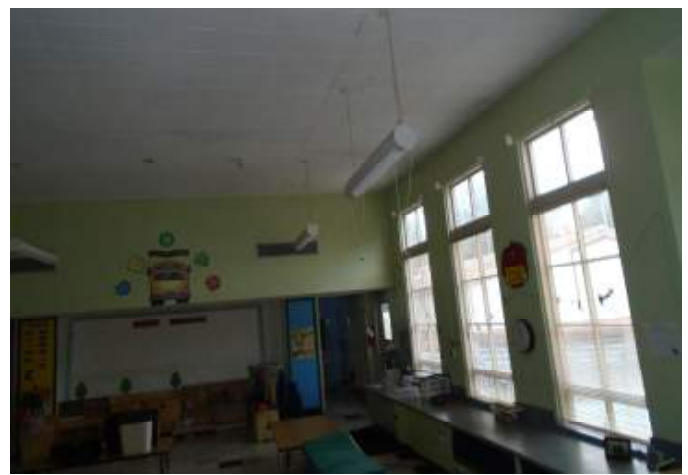
Fig 6. Window wall at typical classroom

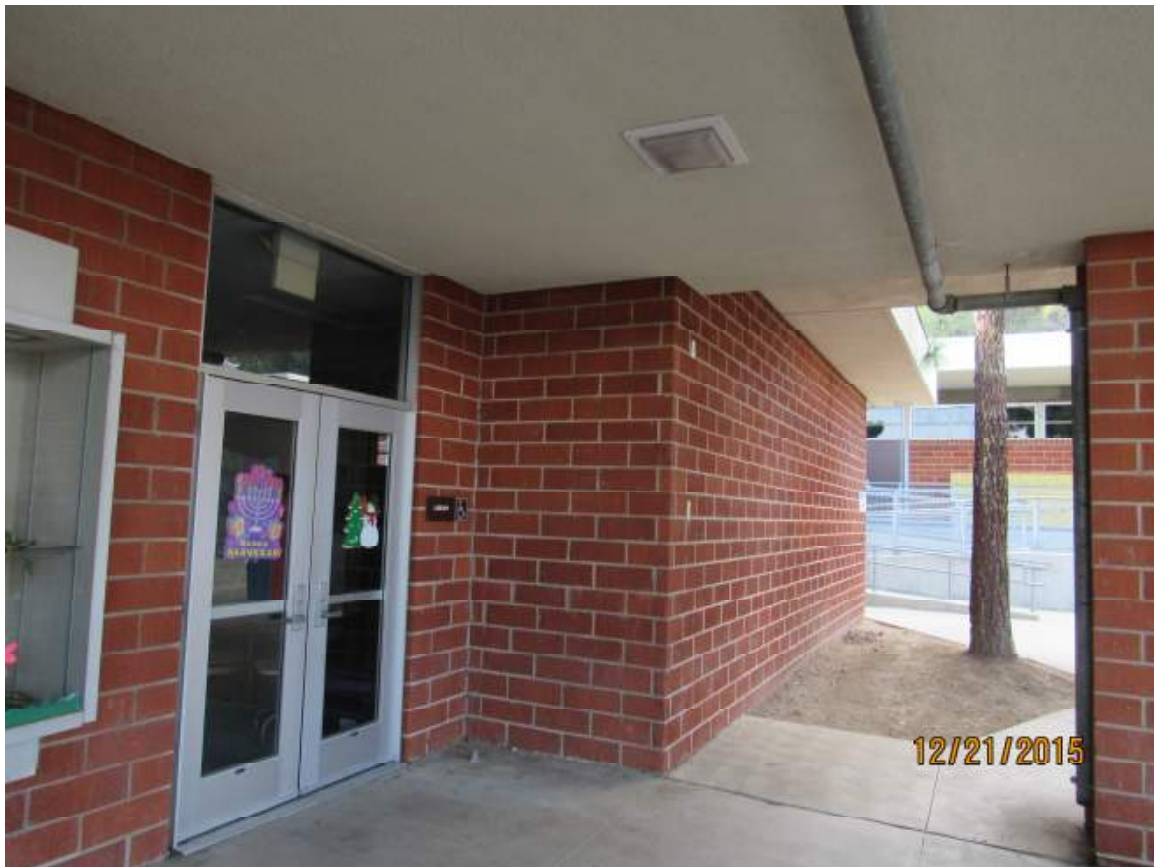
Photo 1 – View of North Entrance of the Library & Admin. Building

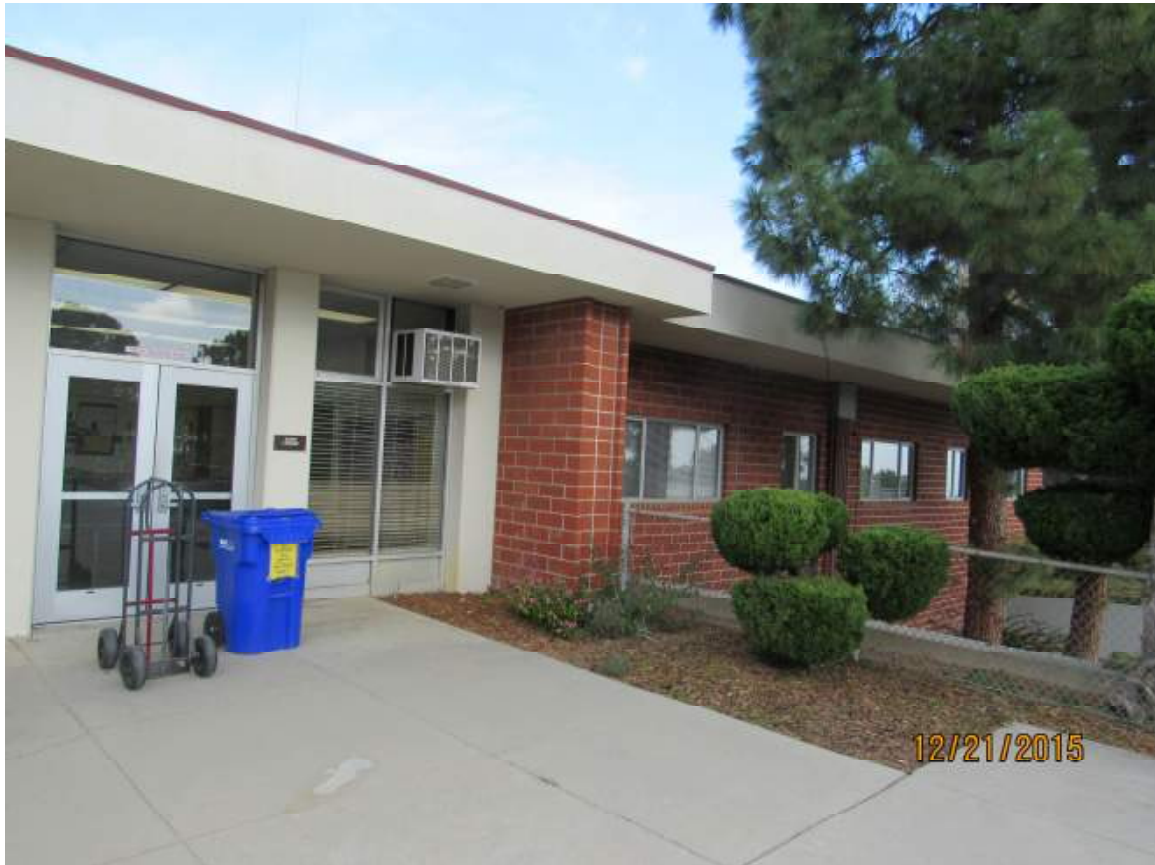
Photo 2 – View of South Entrance of the Library & Admin. Building

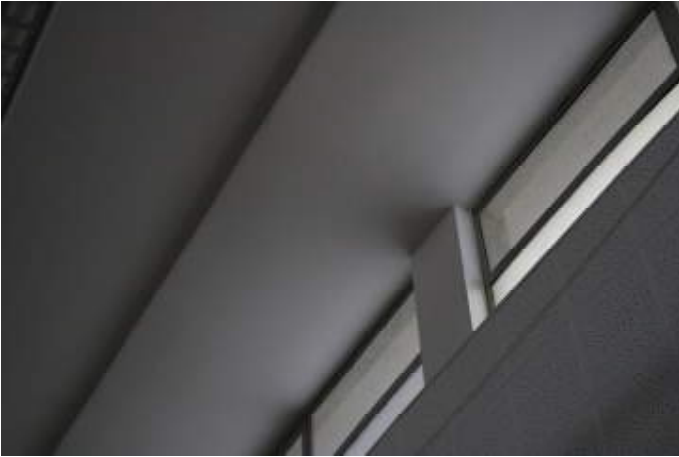
Fig 1. High ceiling with clearstory over the library

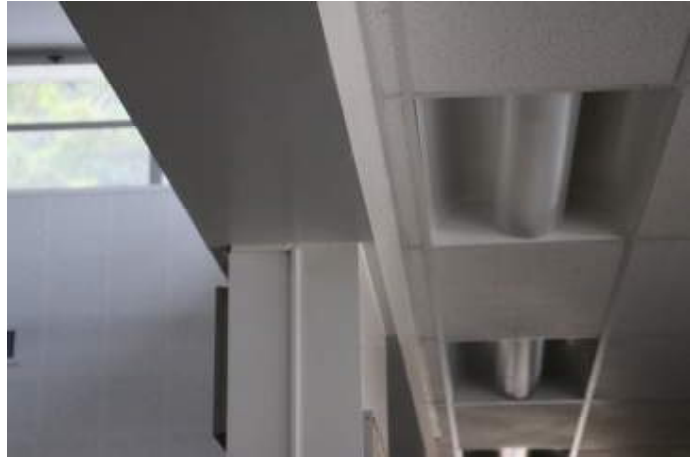
Fig 2. Lower ceiling transition in the library

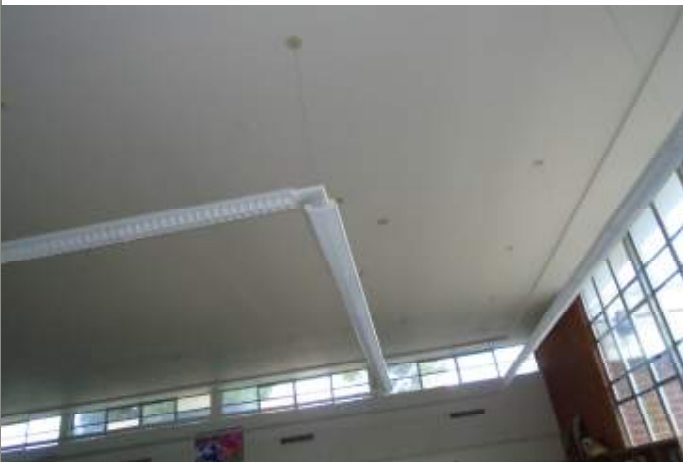
Fig 3. High ceiling in the library

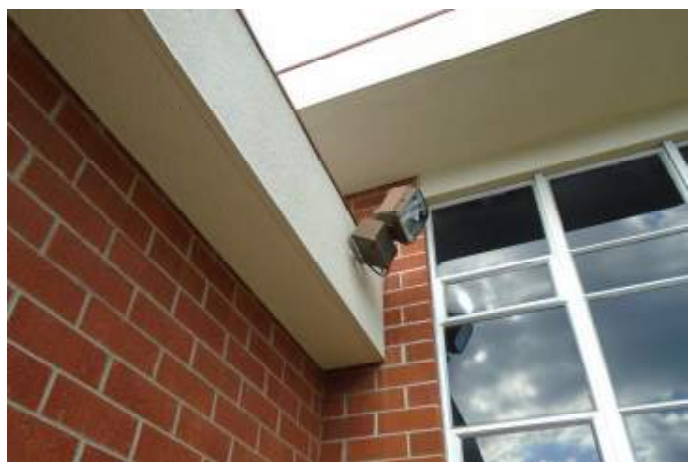
Fig 4. Exterior soffit at high roof at the library

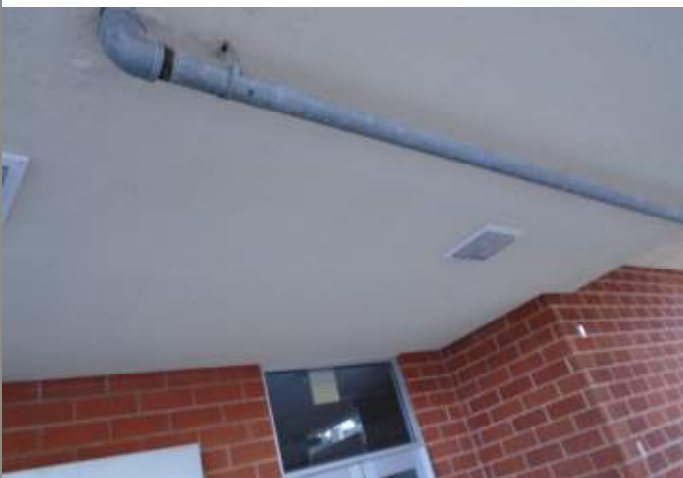
Fig 5. Lower soffit at library entry

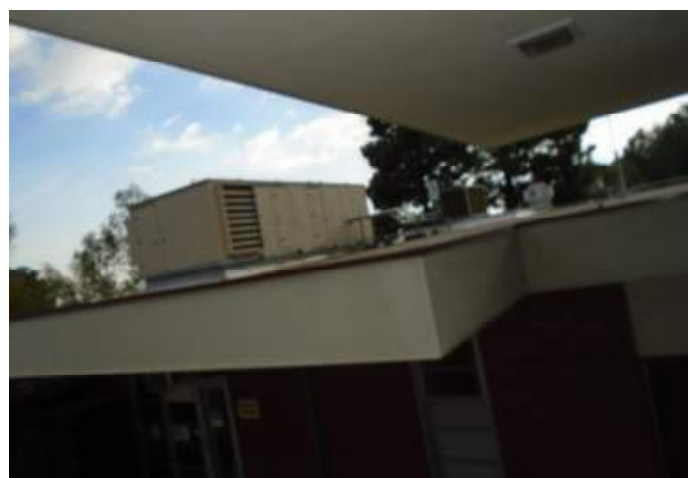
Fig 6. Classroom wing adjacent to library

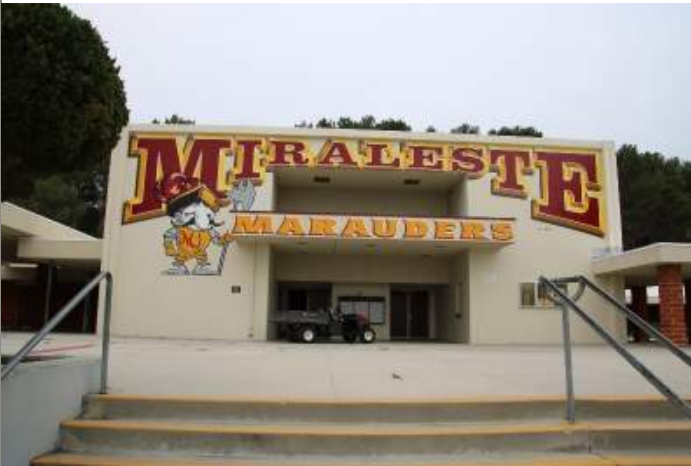
The Load Path deficiency is due to the fact that the precast panels do not have foundations directly underneath them. The precast panels are connected to concrete columns on each side of the precast panel and the lateral forces are then transferred to the foundation via columns. The shear capacity at the column section is often not sufficient, therefore resulting in load path deficiency, which may result in the partial or total collapse of the building. The deficiency of precast panels is the cause of the deficiency in load path. The above identified deficiencies are major structural deficiencies and pose a serious collapse hazard if they are not mitigated.

Fig 1. Precast wall panels at front of MP room

Given the reasons above, a voluntary seismic retrofit is recommended for this structure to mitigate these deficiencies.

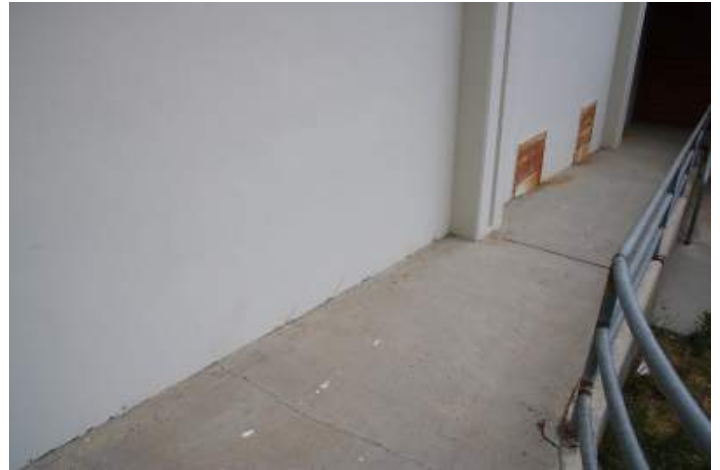
Fig 2. Exterior ramp adjacent to wall panels

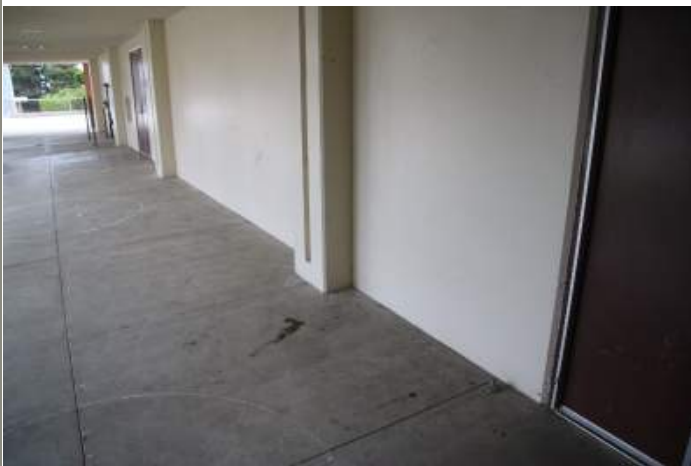
Fig 3. Covered walkway adjacent to wall panels

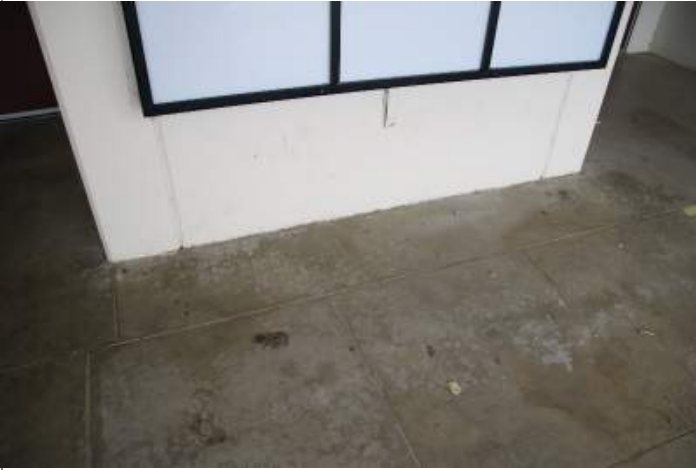
Fig 7. Wall panels at entry ticket booth from exterior

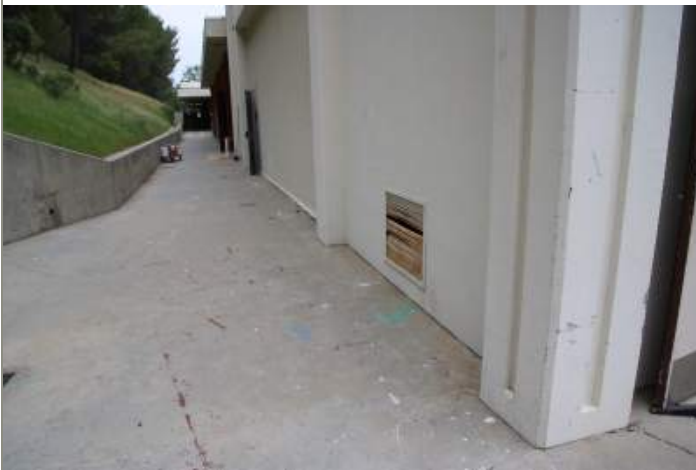
Fig 8. Elevated area at wall panels behind the stage

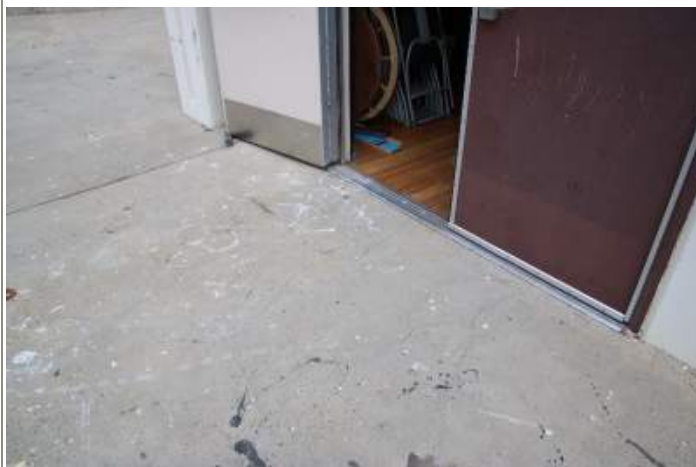
Fig 9. Elevated entry to the stage through wall panel

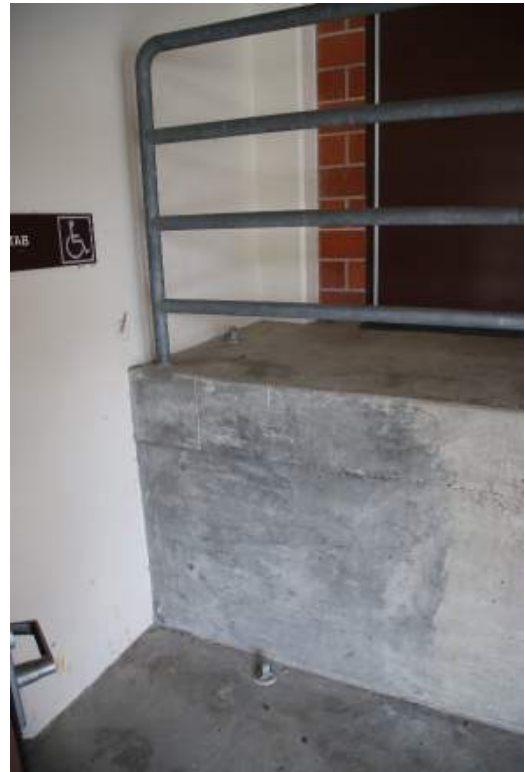
Fig 10. Exterior stair to elevated room adjacent to wall panels

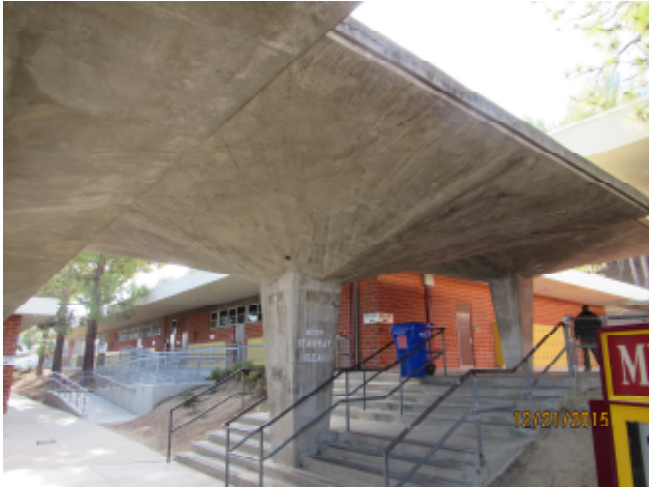
Fig 1. Building C with shade canopies in front

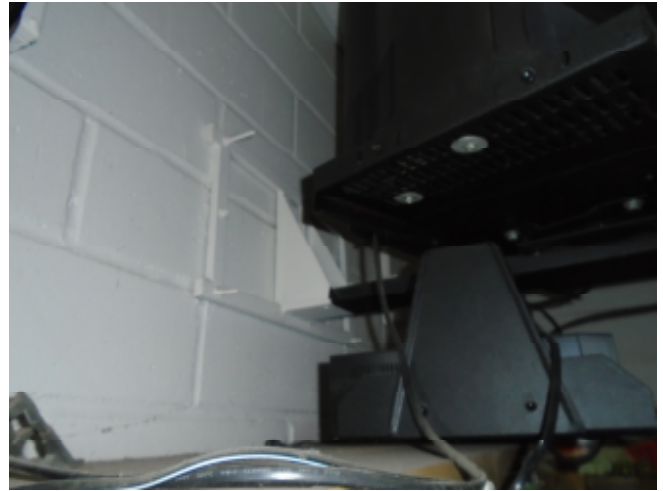
Fig 2. Equipment mount above ceiling

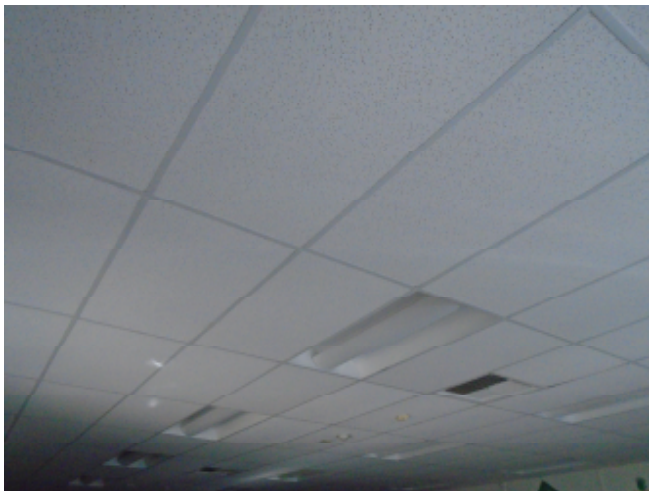
Fig 3. Typical suspended ceiling & lighting

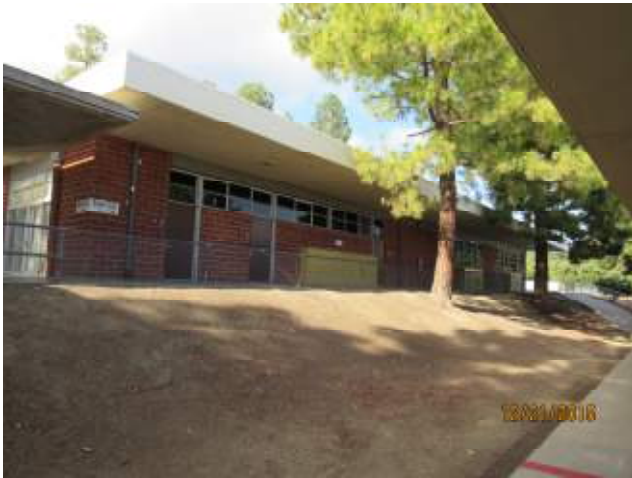
Fig 1. Exterior adjacent to slope

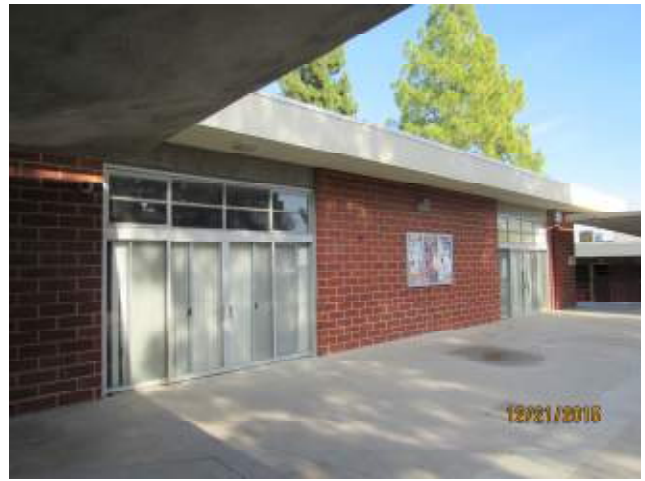
Fig 2. South end with large openings

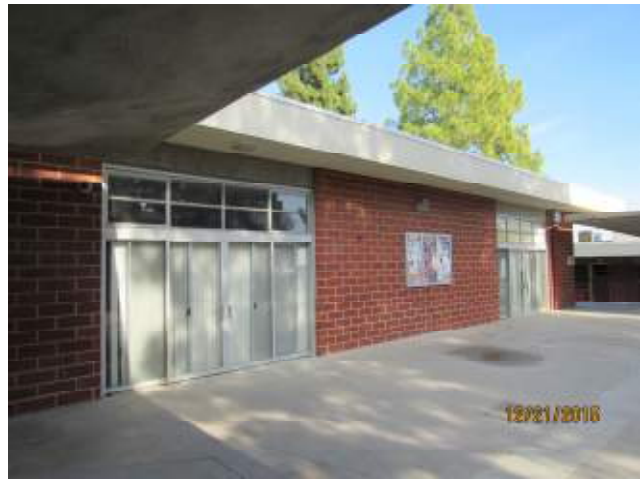
Fig 2. South end with large openings

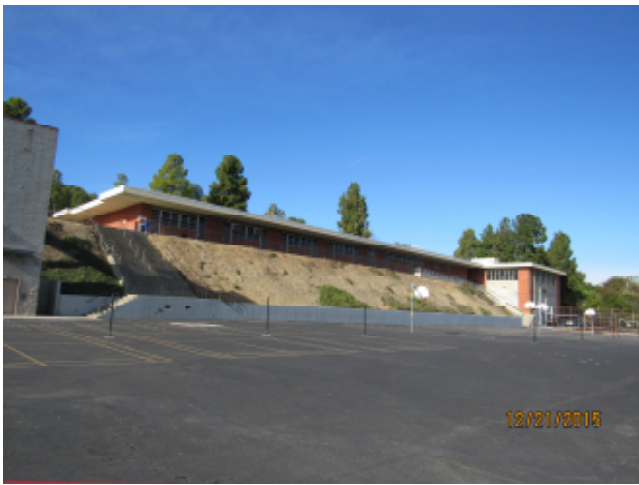
Fig 1. Terrace slope

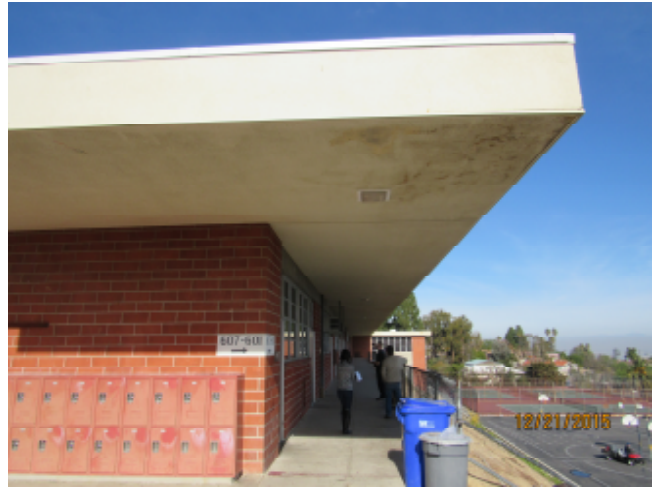
Fig 2. Circulation walk with overhang

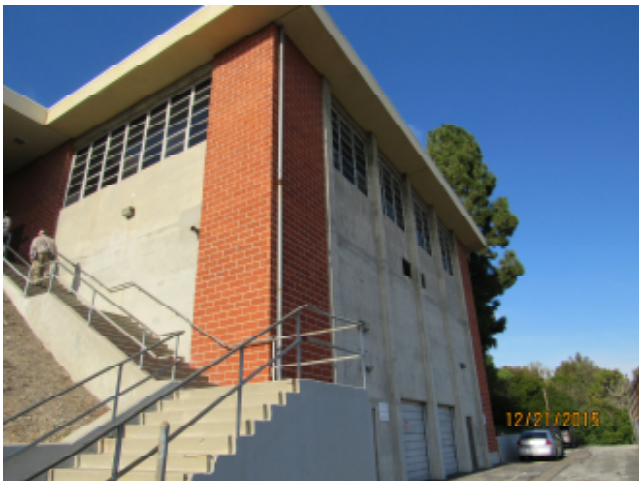
Fig 3. Exposed basement

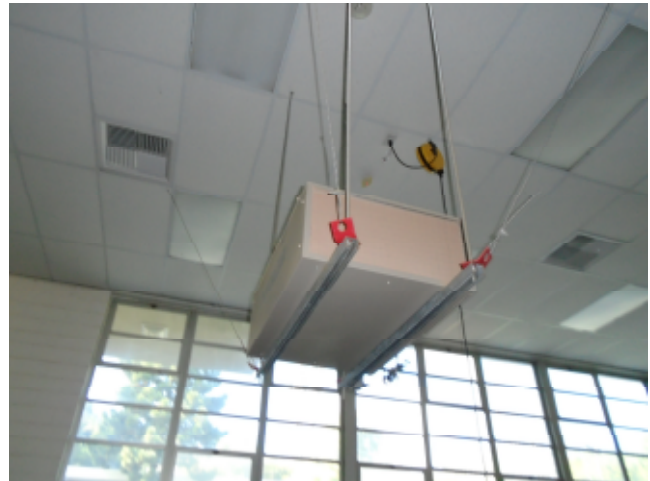
Fig 4. Shop ceiling with HVAC unit

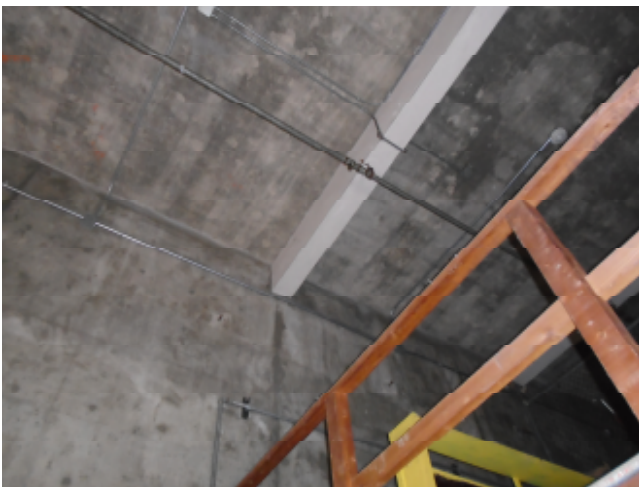
Fig 5. Basement storage area

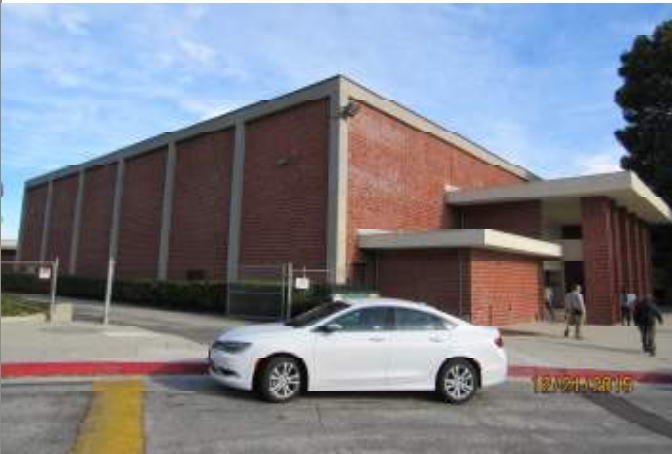
Fig 1. Gymnasium structure with lobby entry

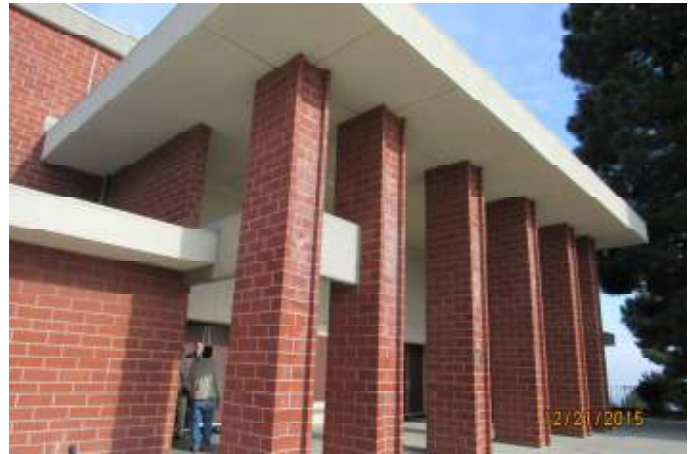
Fig 2. Lower roof at lobby entry

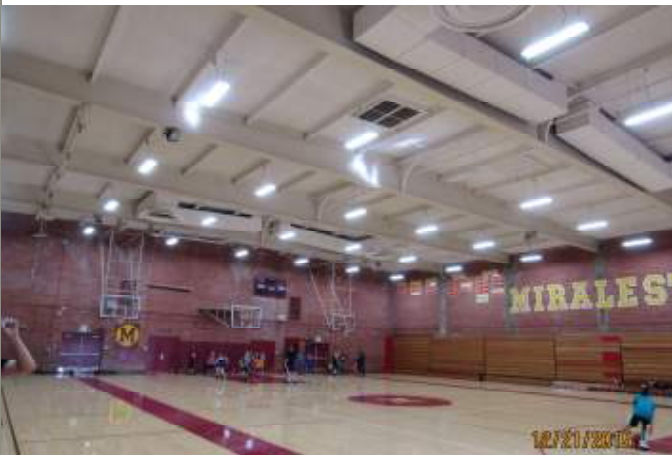
2. The “other diaphragms” deficiency is due to the fact that the gymnasium roof diaphragm consists of reinforced gypsum concrete which is a diaphragm other than wood, metal deck, concrete or horizontal bracing. Reinforced gypsum is brittle and has limited strength. The existing reinforced gypsum concrete diaphragm was confirmed to be inadequate.

Fig 3. Gymnasium roof structure

2. Other diaphragms. We recommend option (b), the addition of horizontal diagonal bracing to the gymnasium roof framing. This option is clearly less invasive than

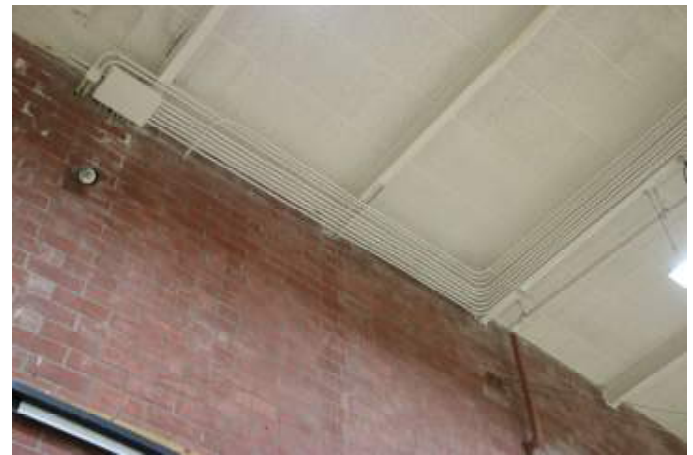
Fig 4. Purlins at masonry wall in gym

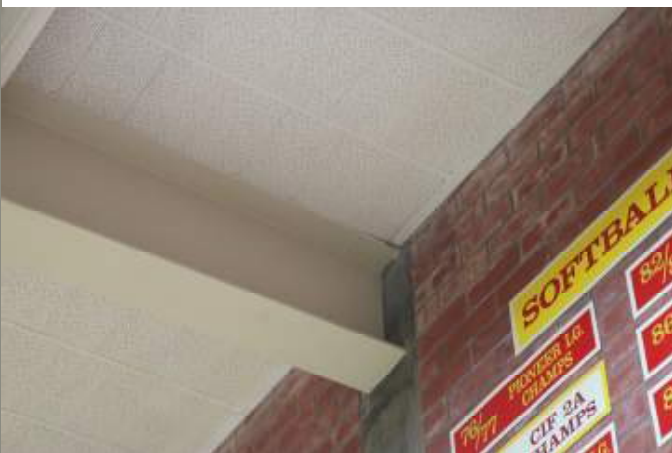
Fig 5. TSG connection at concrete column in gym

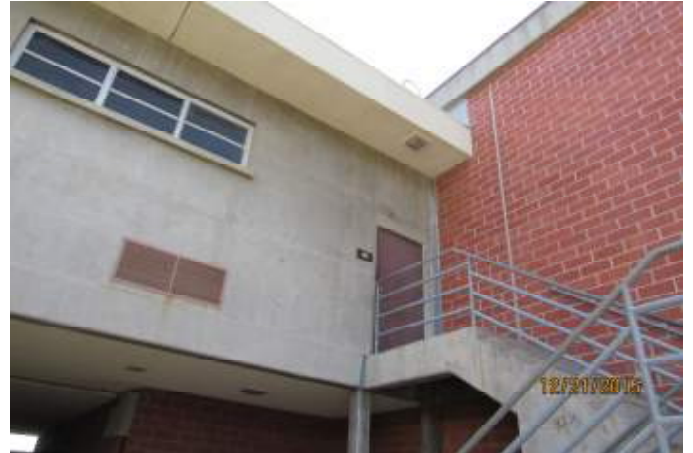
Fig 6. Locker building connection to gymnasium

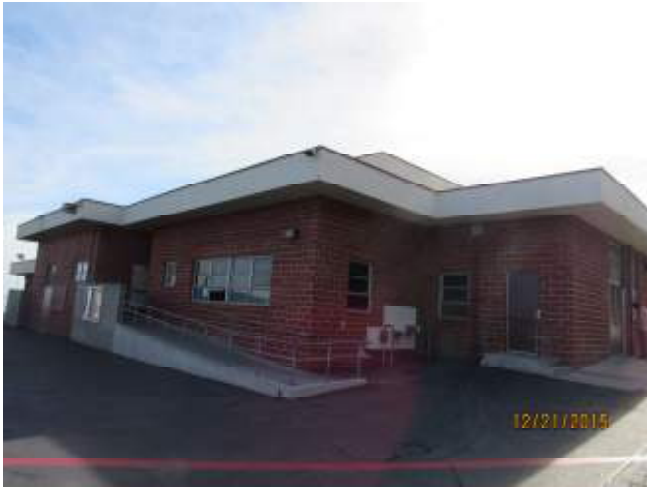
Fig 1. North end of locker room building

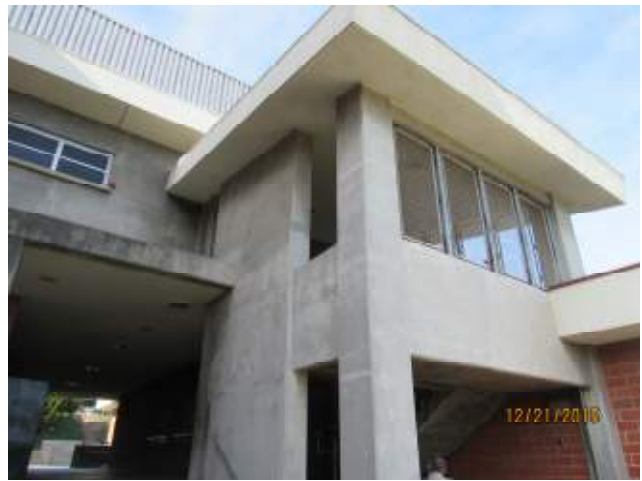
Fig 2. Two story circulation connection to gym.

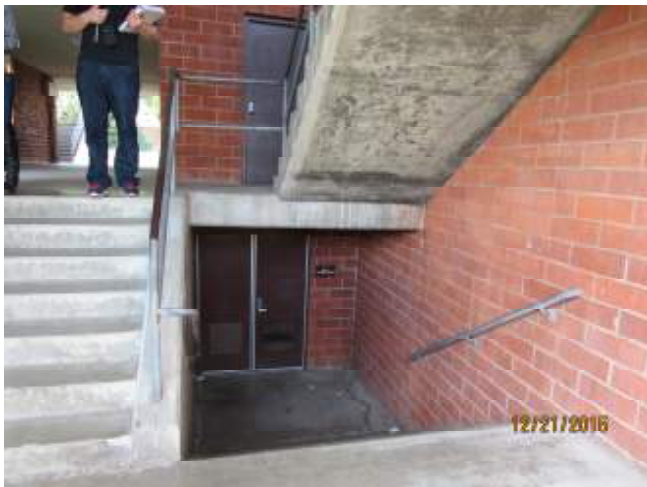
Fig 3. Circulation from gym to lockers

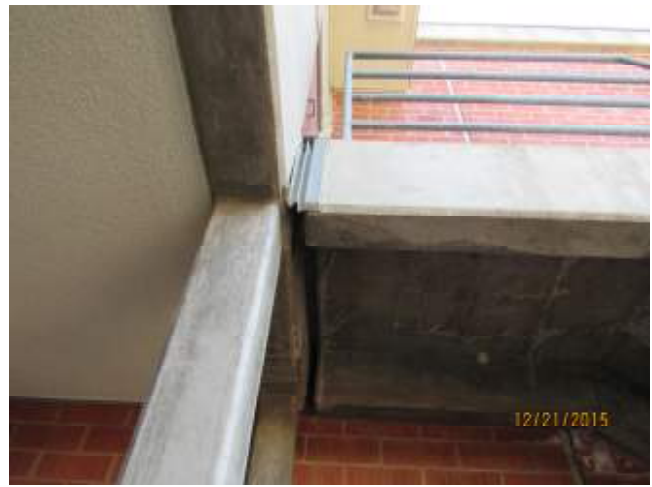
Fig 4. Structural separation at circulation

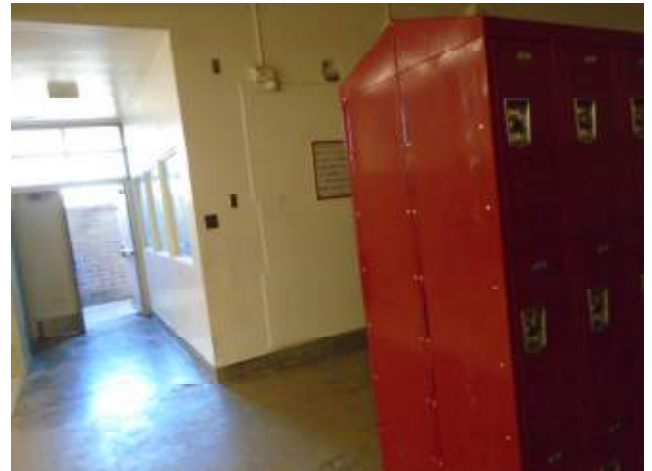
Fig 6. Locker room interior

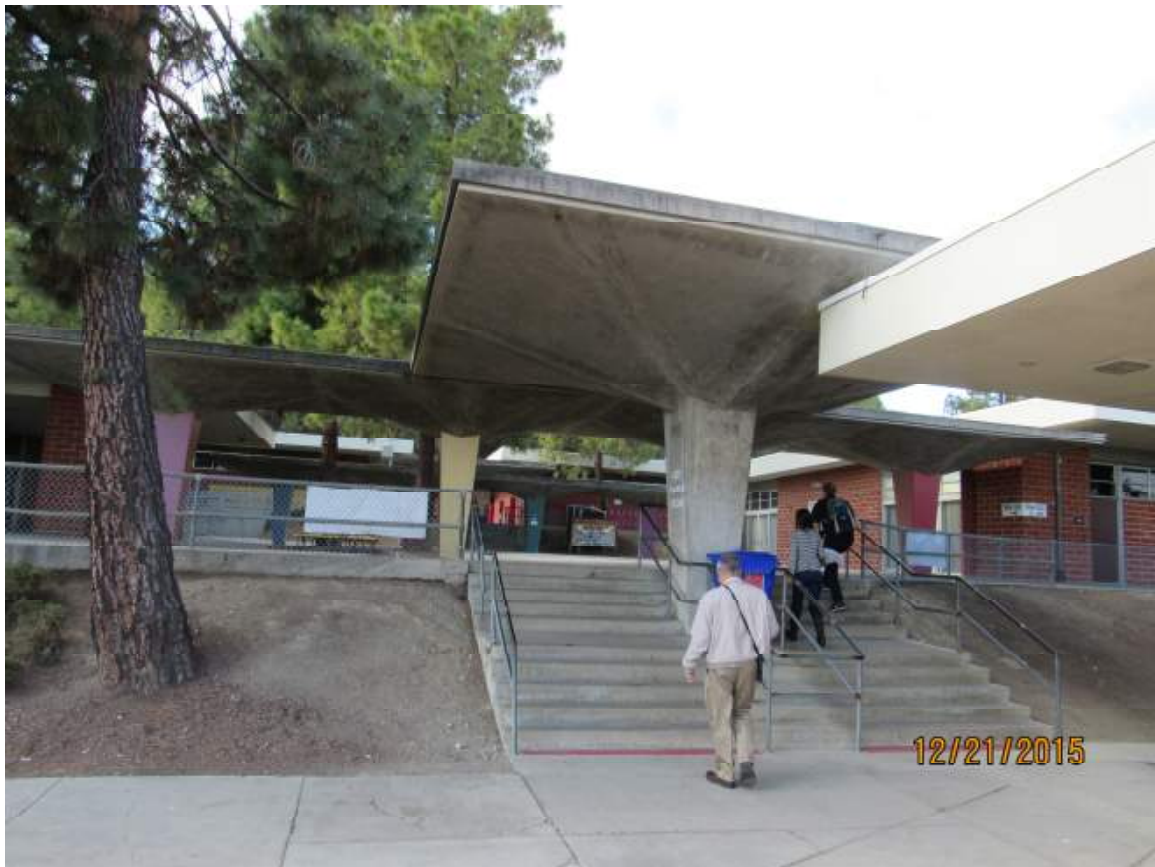
Photo 1 – View of Concrete Canopy

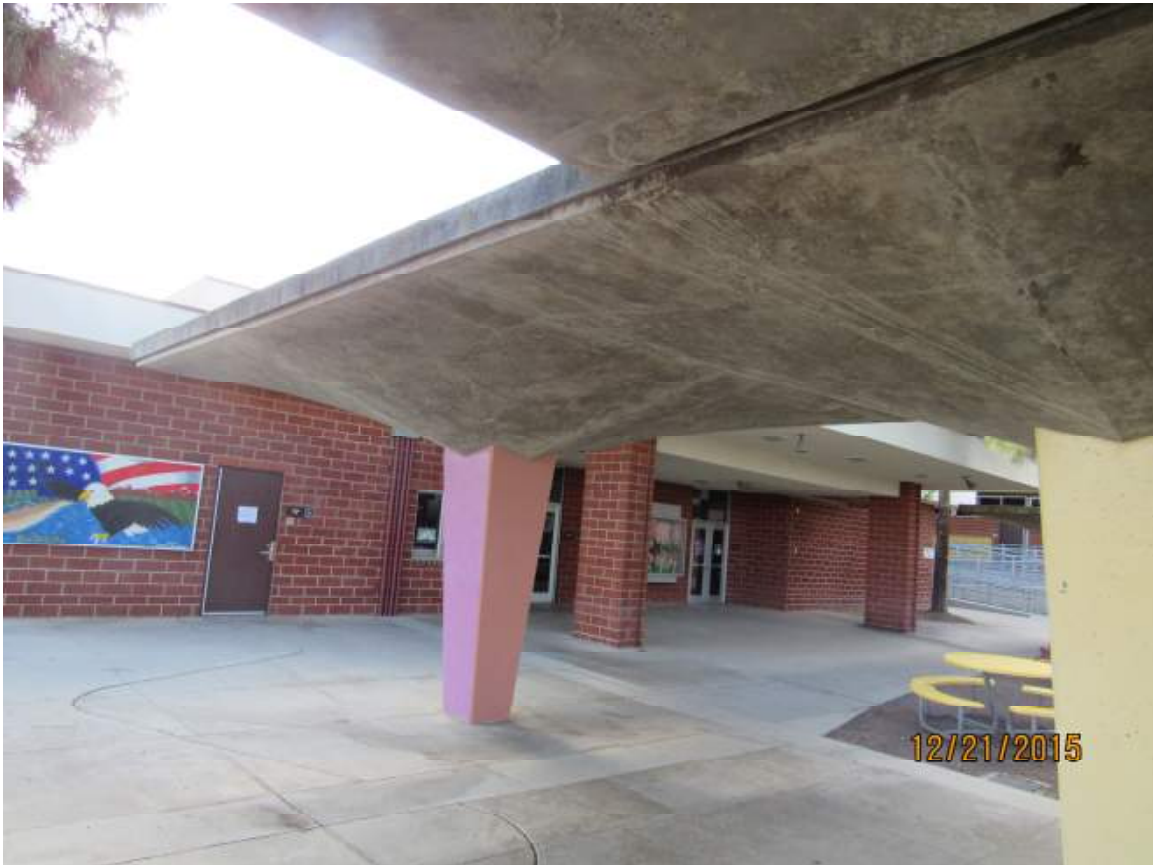
Photo 2 – View of Concrete Canopy

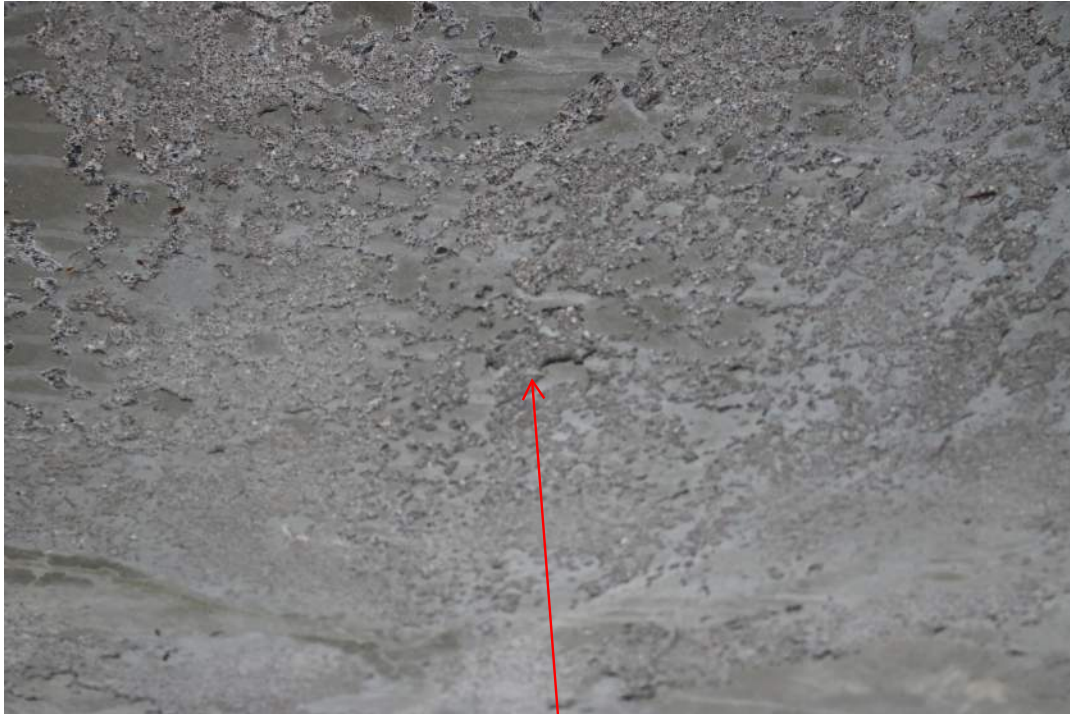
FIG. 3

COSMETIC SURFACE
DE-LAMINATION ON THE
UNDERSIDE FROM MOISTURE
MIGRATING BY GRAVITY
THROUGH THE DECK.

Spalling Concrete Repair

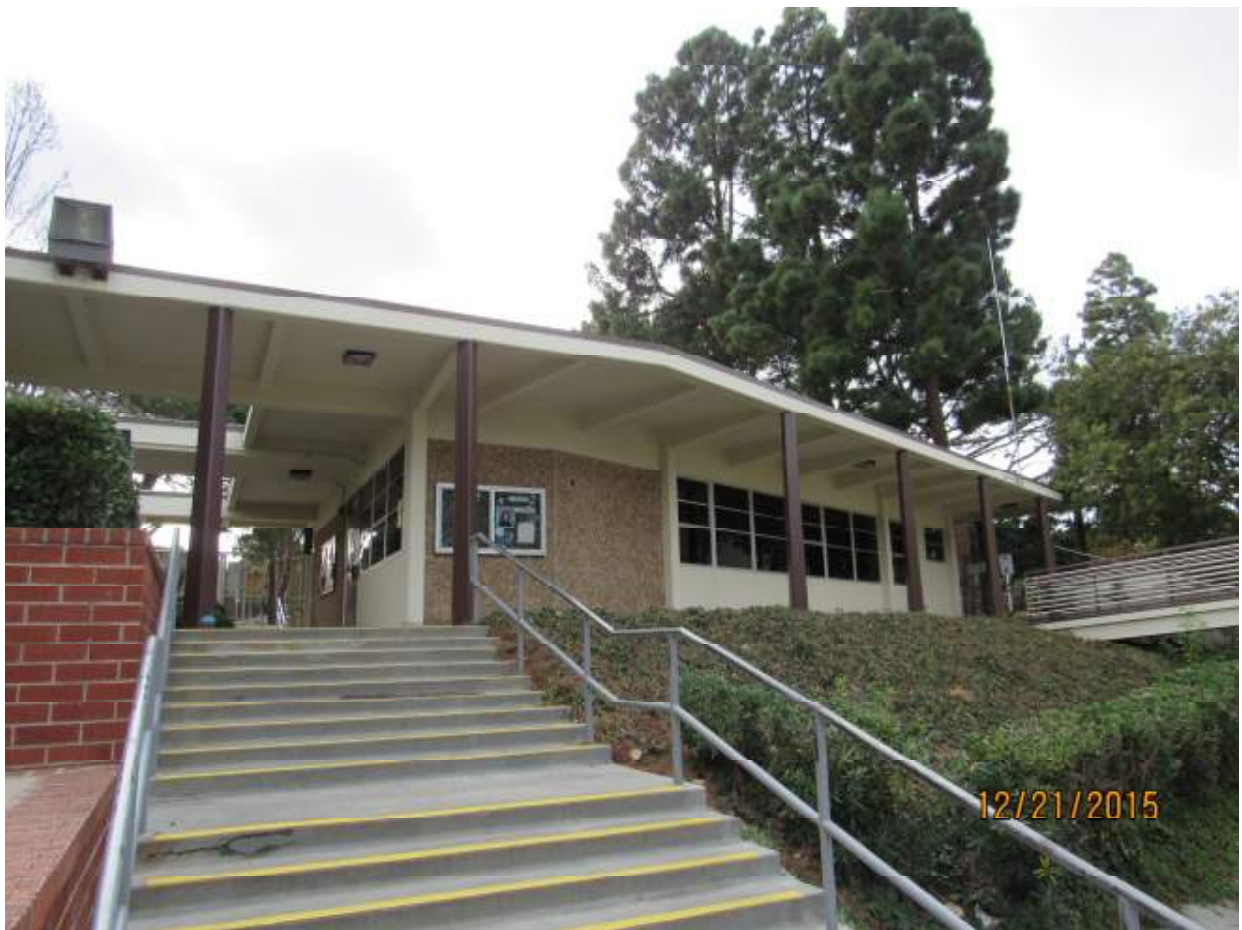
Photo 1 – Northern Elevation of Administration Building
