Palos Verdes Peninsula Unified School District

Seismic Structural Evaluation and Recommendations

September 9, 2016

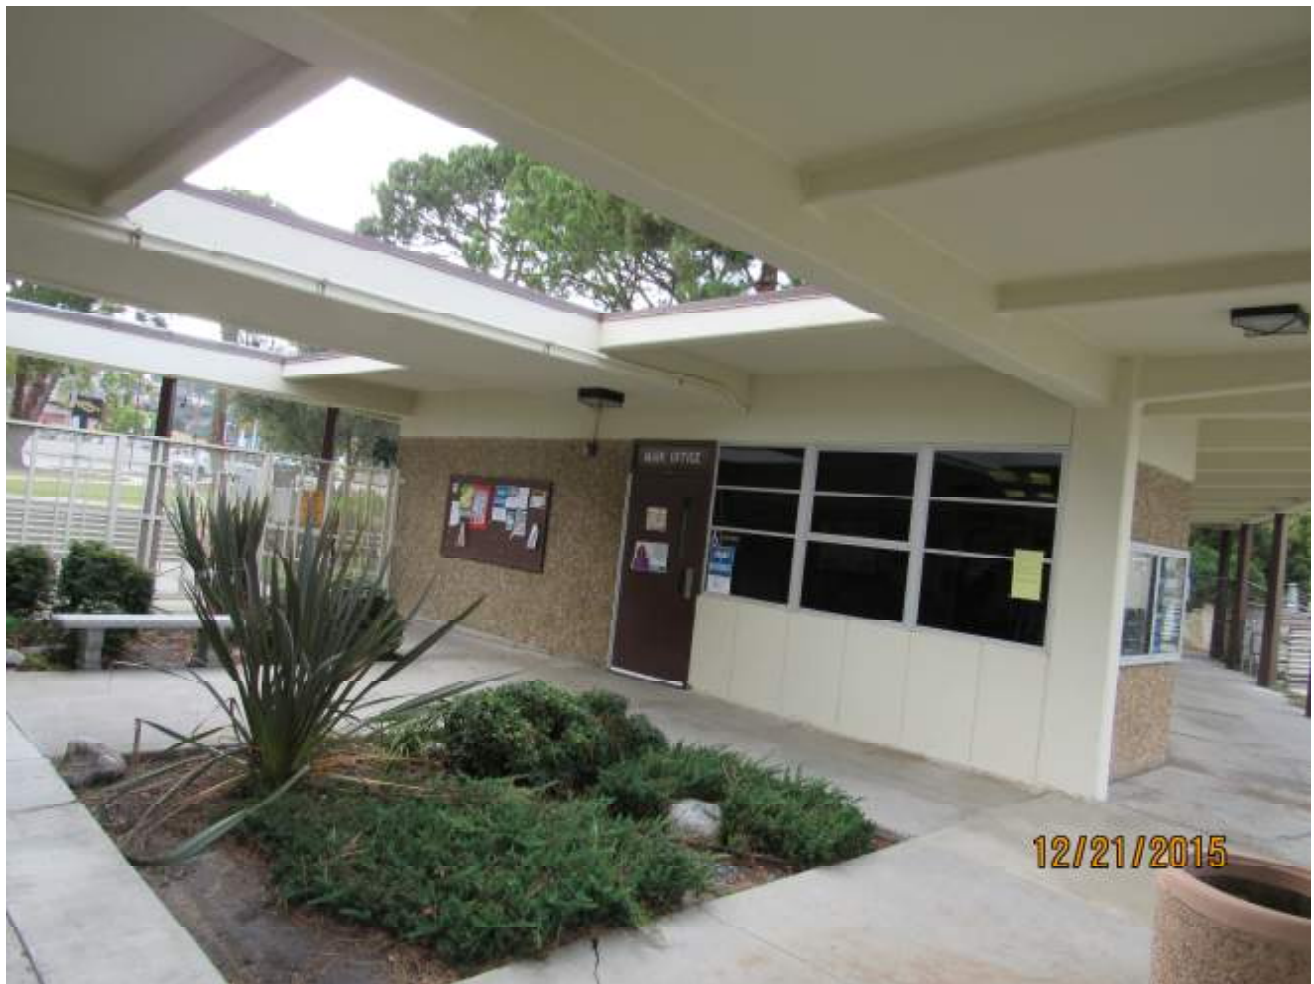
Photo 2 – Underpass between two buildings of Admin. Building

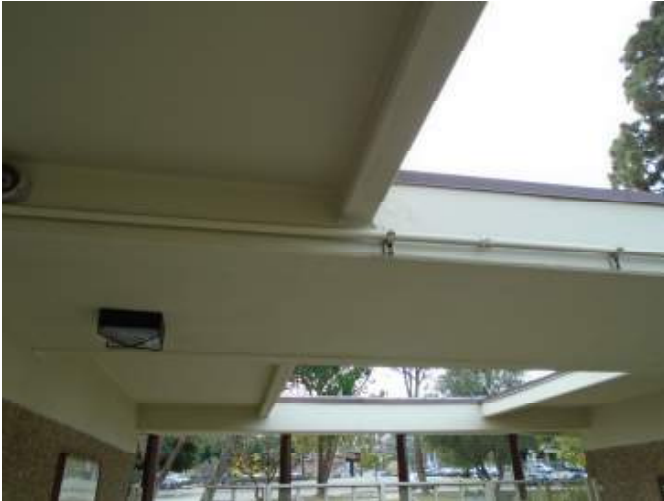
Fig 1. Covered open area in the middle

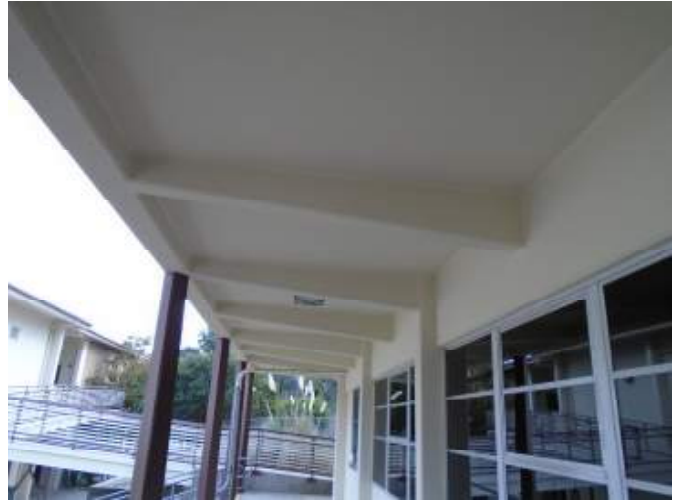
Fig 2. Perimeter walkway

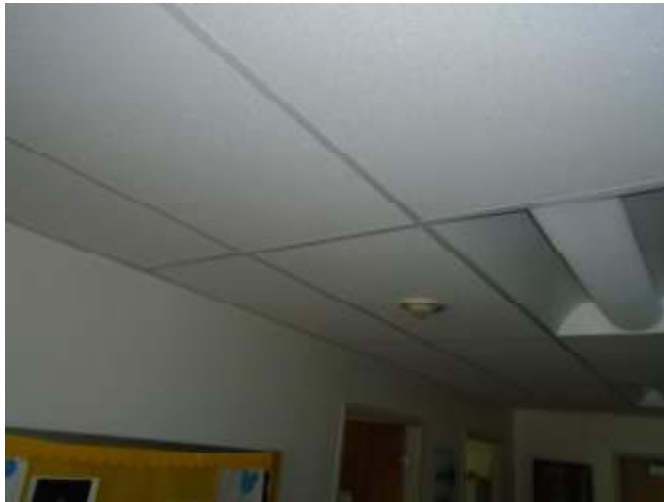
Fig 3. Interior corridor with newer ceilings

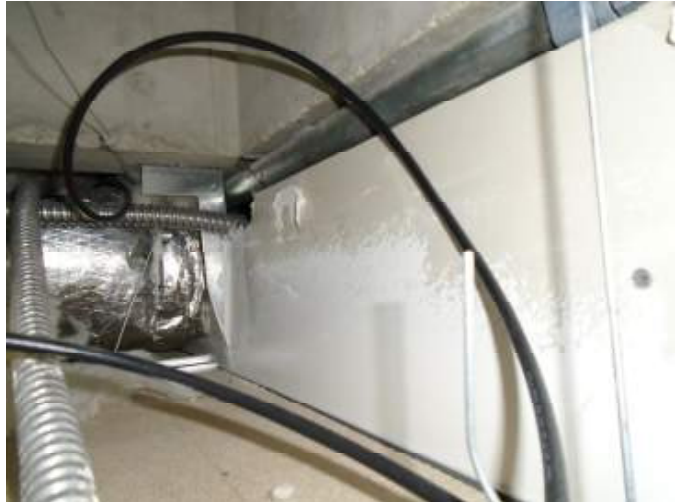
Fig 4. Typical above ceiling condition

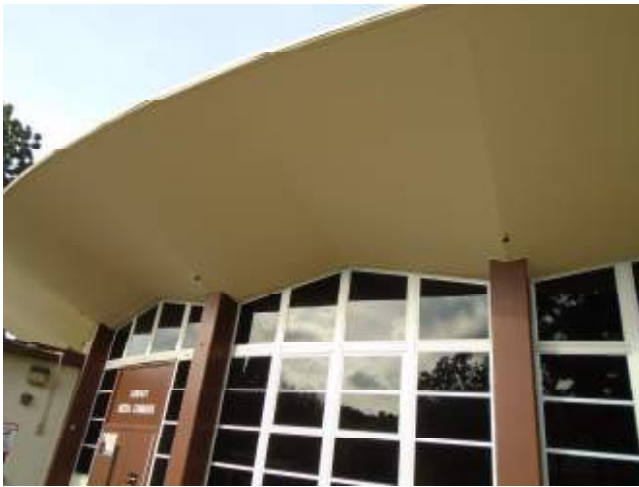
Fig 1. Folded plate roof and support piers from exterior

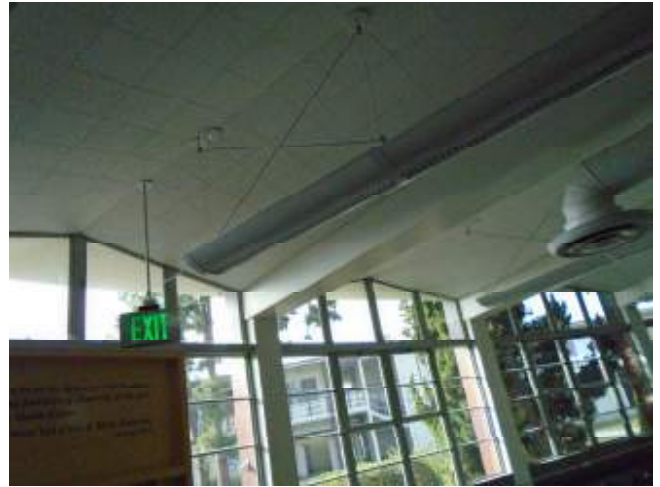
Fig 2. Folded plate roof from interior

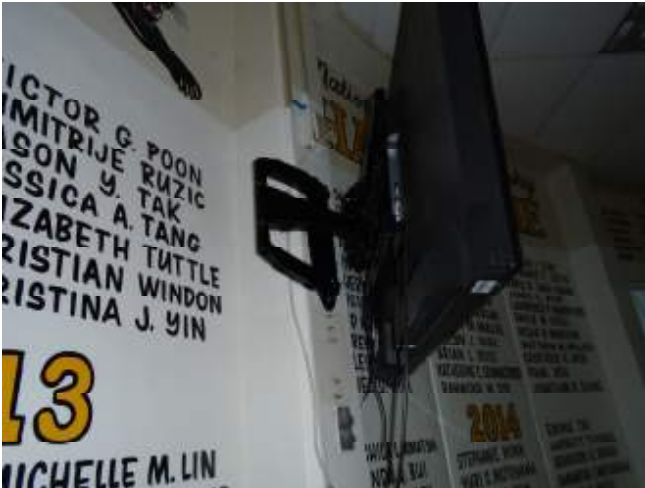
Fig 3. Interior core walls from inside

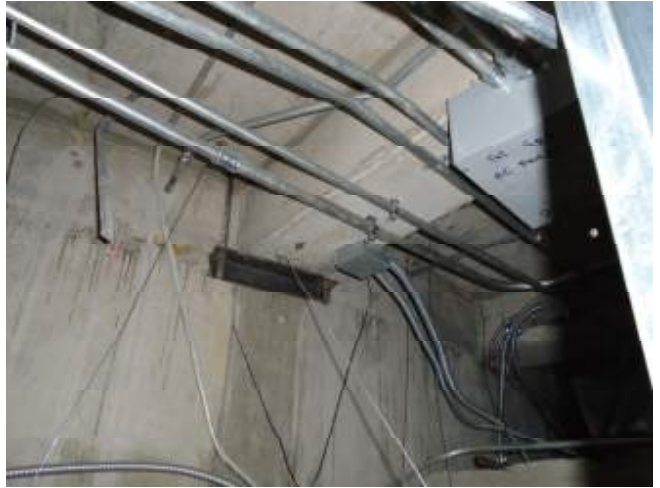
Fig 4. Interior core walls from outside with folded plate roof and beams

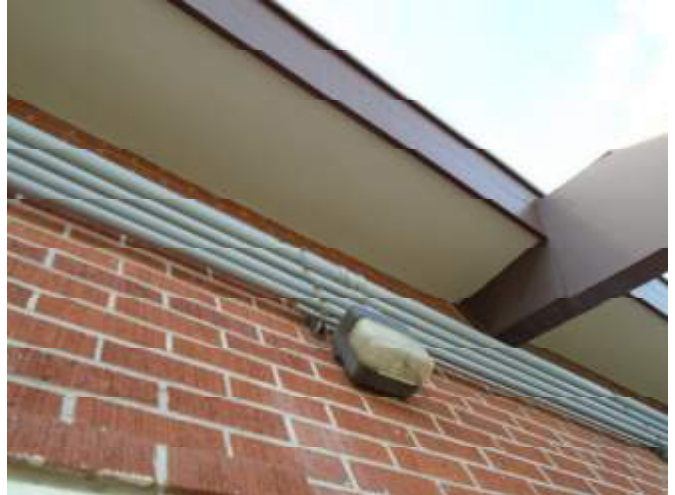
Fig 2. Masonry side wall & glue lam arch with sheet metal protection

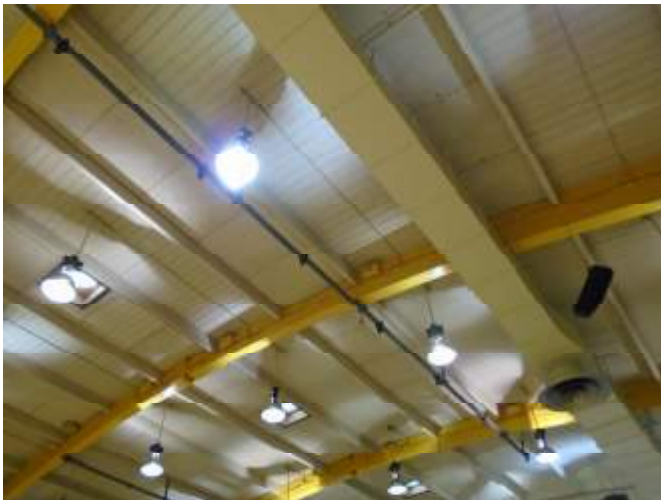
Fig 3. Glue lam roof support arches inside the gym

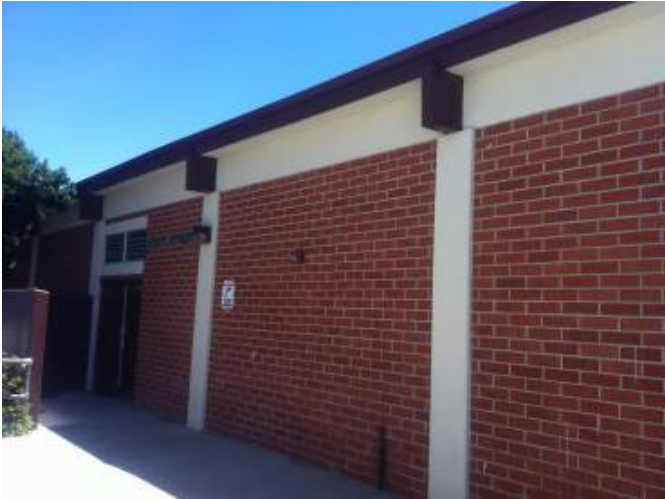
Fig 1. Exterior masonry wall with concrete piers

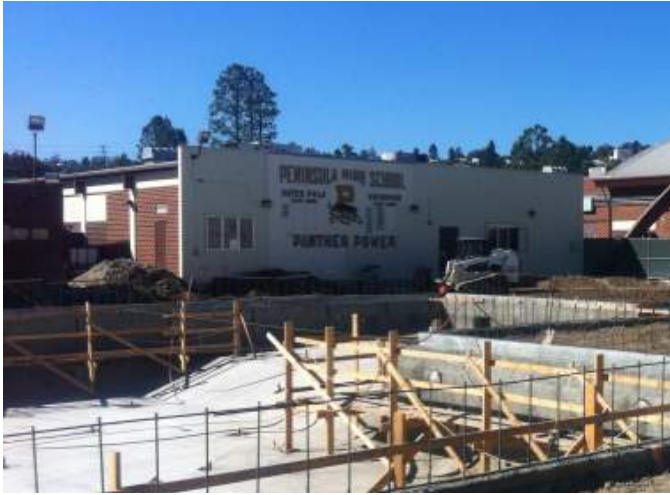
Fig 1. Concrete exterior end walls

It is recommended to maintain the roof system in good repair to minimize any deterioration of the wood roof framing system. It is also recommended to maintain the exposed ends of the glue laminated beams that support the roof.

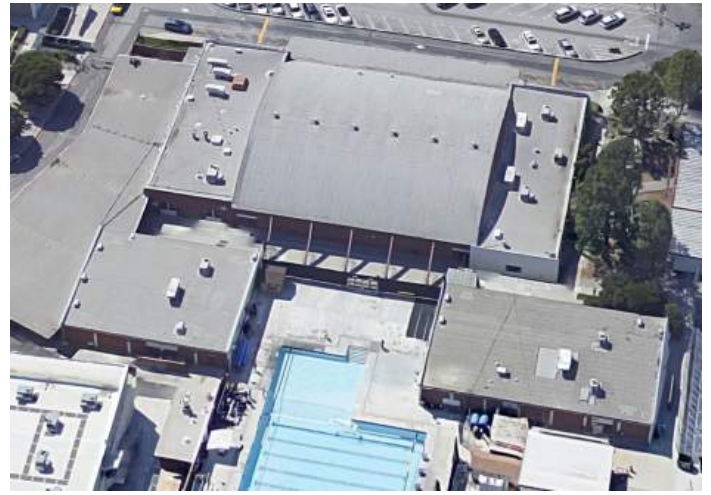
Fig 2. Locker rooms and gym context

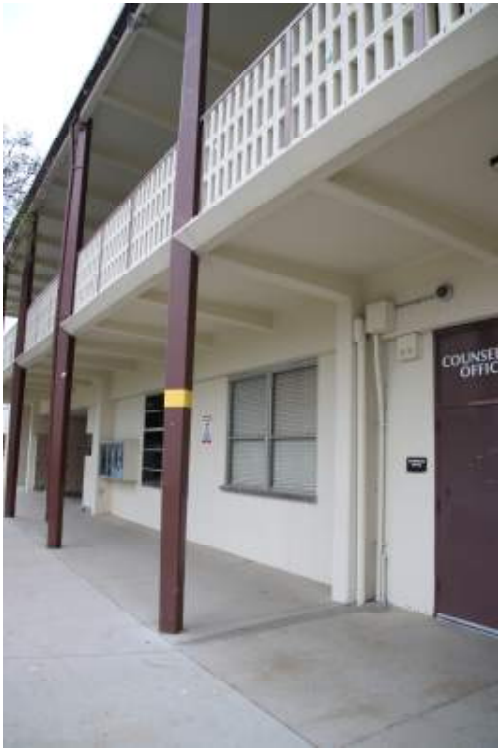
Fig 1. pier wall along grid 8

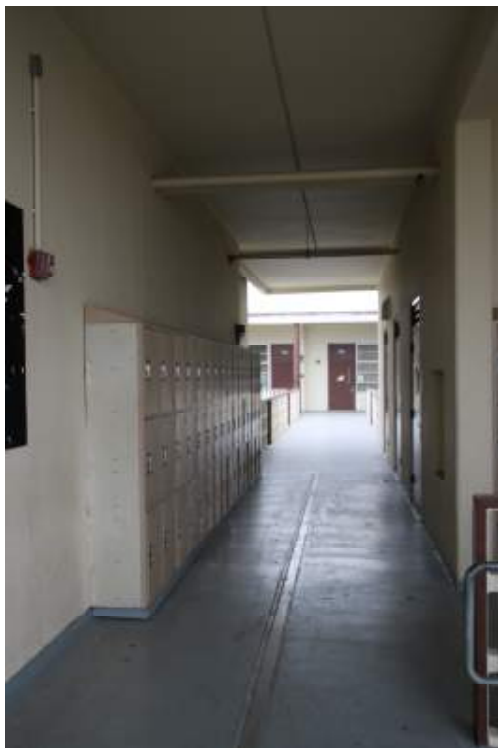
SUMMARY: BOTH WALL SEGMENTS ALONG GRIDS E & I
ARE NON-COMPLIANT FOR FLEXURE. RETROFIT
METHOD WILL BE RECOMMENDED IN REPORT.

Fig 4. Walls along grid E & D.7 at 2nd floor

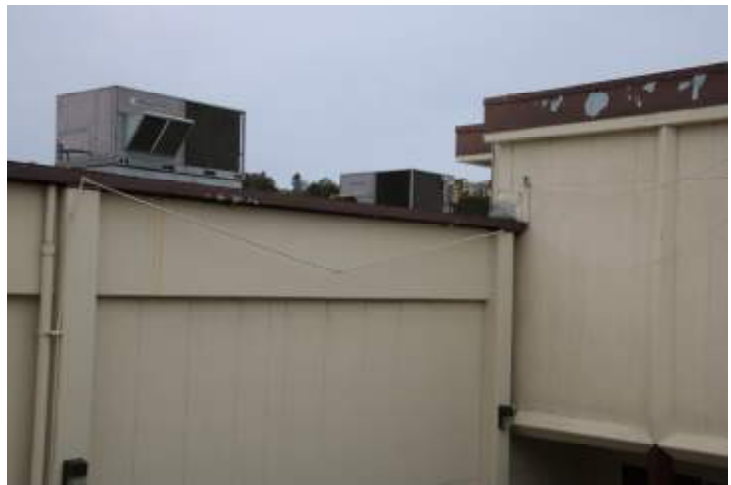
Fig 2. Lower steel roof at grid F

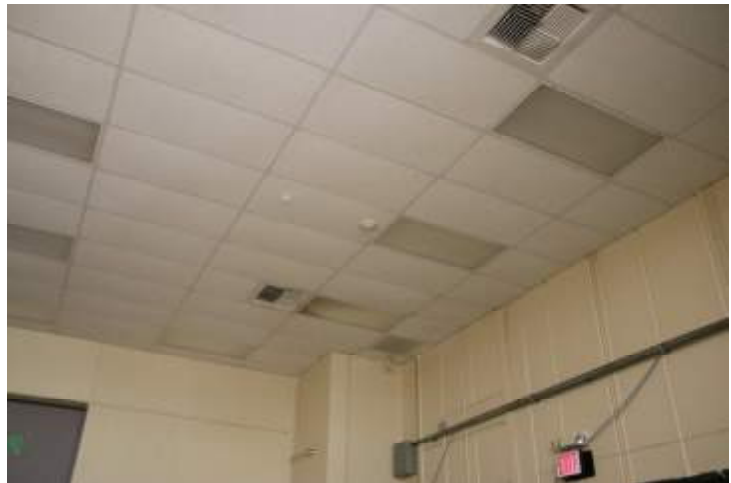
Fig 3. Ceiling in area below steel roof at grid F

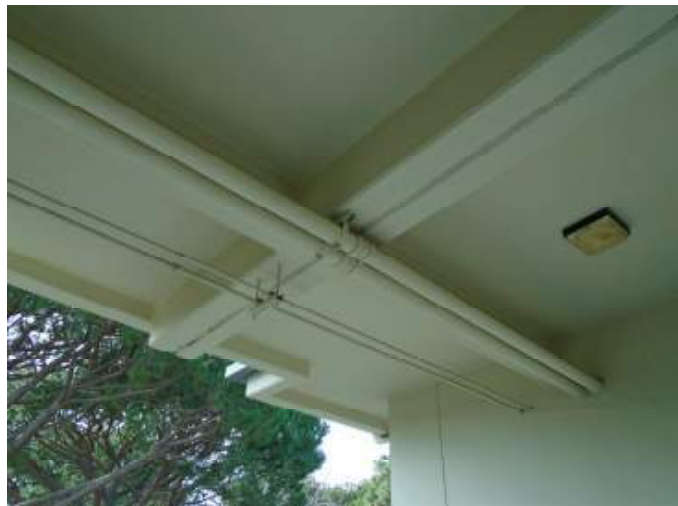
Fig 5. Wall/coupling beam along grid line E 1st floor

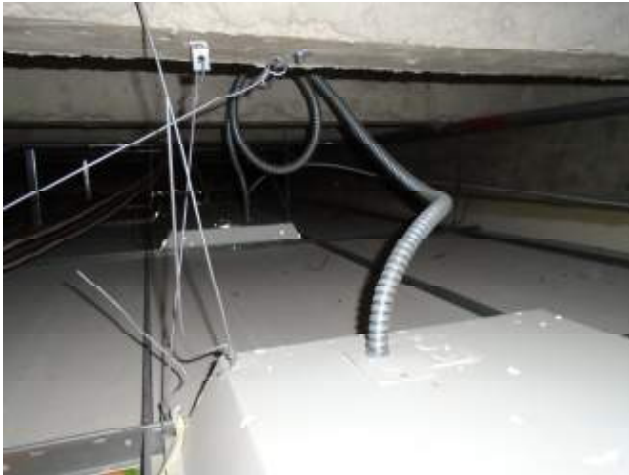
Fig 6. Typical above ceiling near coupling

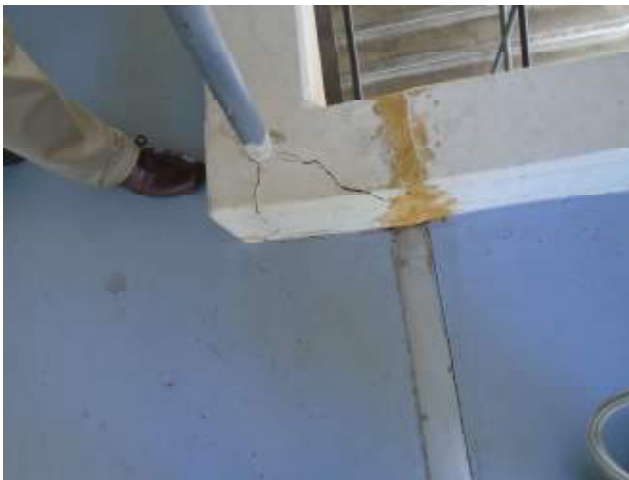
Fig 8. Cracked concrete at guard rail

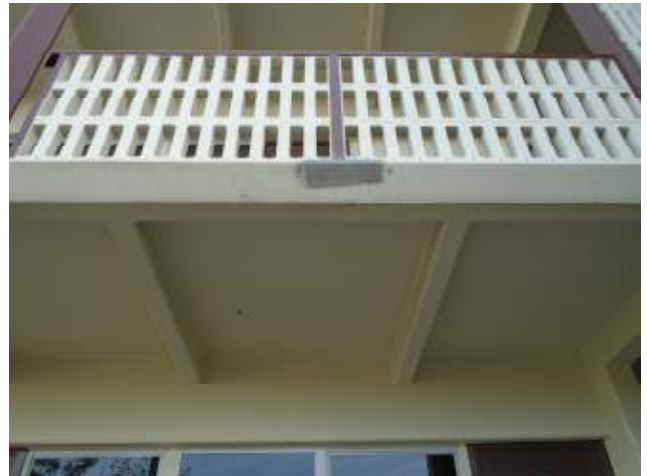
Fig 9. Existing recent spawled concrete repair
